# Comprehensive SEE Qualification

CNES/ESA Radiation Effects Final Presentation Days 2017  
ESTEC - 9-MAR-2017

Funded under ESA Contract no. 4000116569

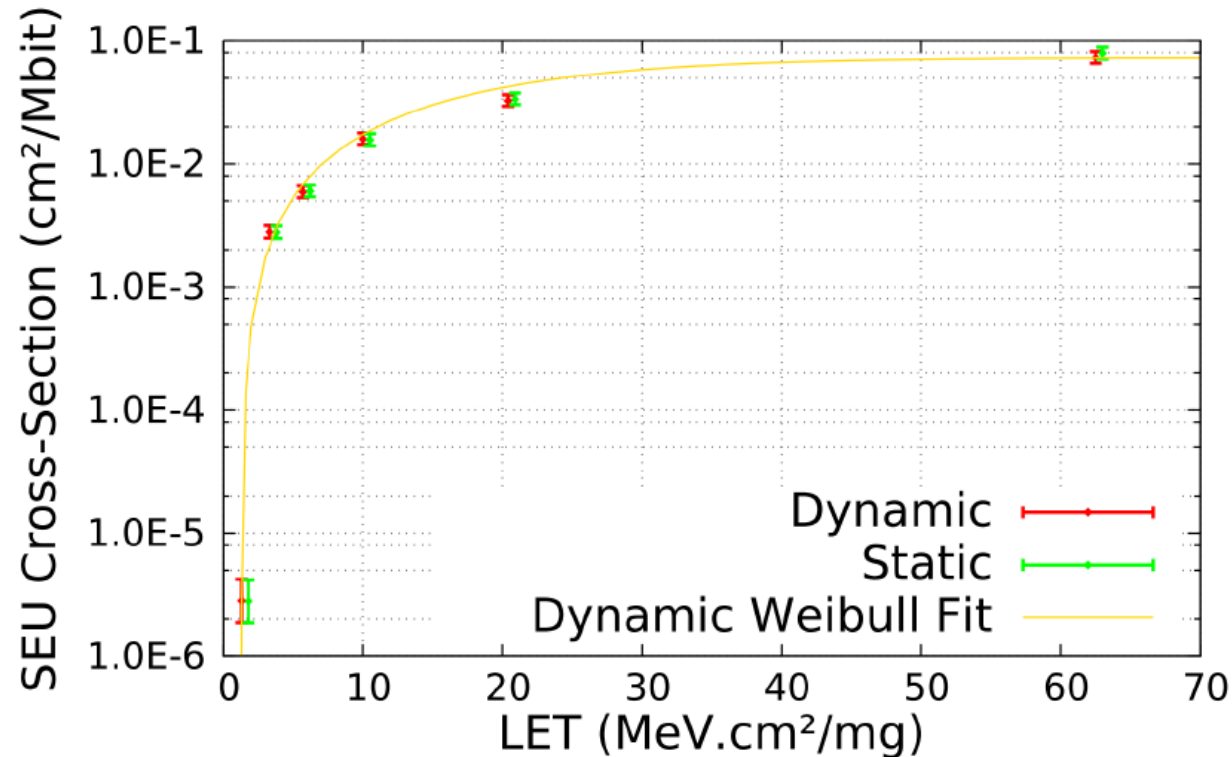
# Renesas R1RW0416DSB

- SEU test results (UCL)
- Static and dynamic test algorithms – very similar

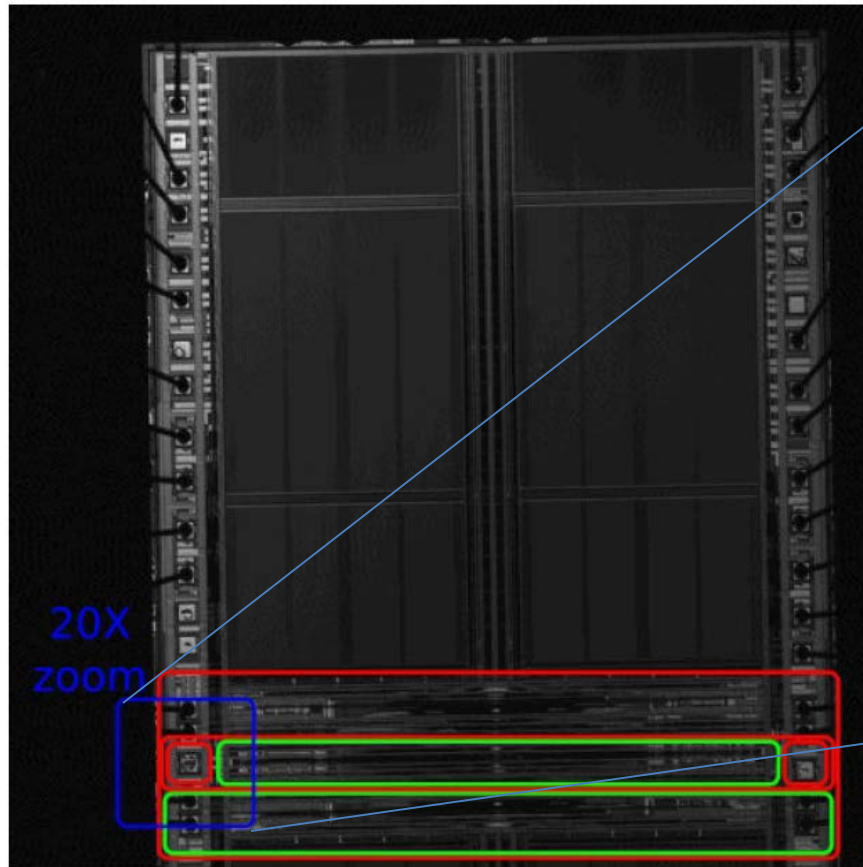
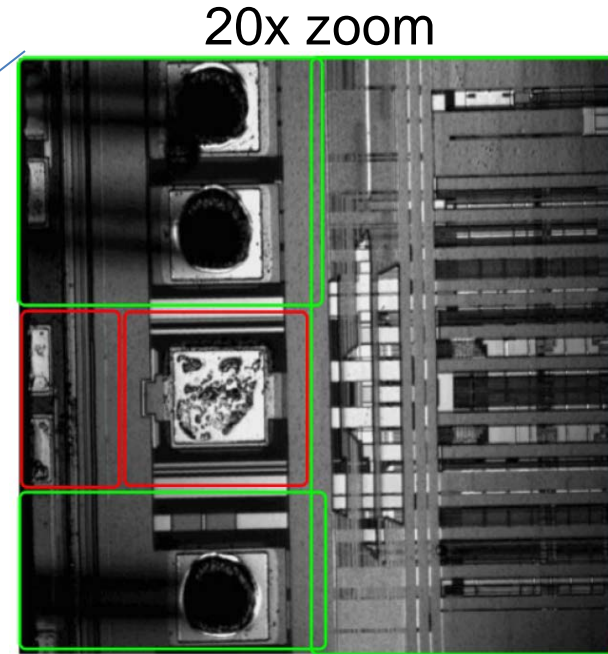
# Laser Investigation

- Red area – TMBUR observed
- Green area – no errors observed
- Sensitive area -> unbonded pad
- Root Cause Analysis underway
