# Space Debris from Spacecraft Degradation Products Final Presentation

Funding programme TRP ; ESA Contract no. 4000113047/14/NL/LF

The project aim was to study the degradation and generation of debris of external spacecraft materials when exposed to long term space environment (for LEO and GEO conditions).

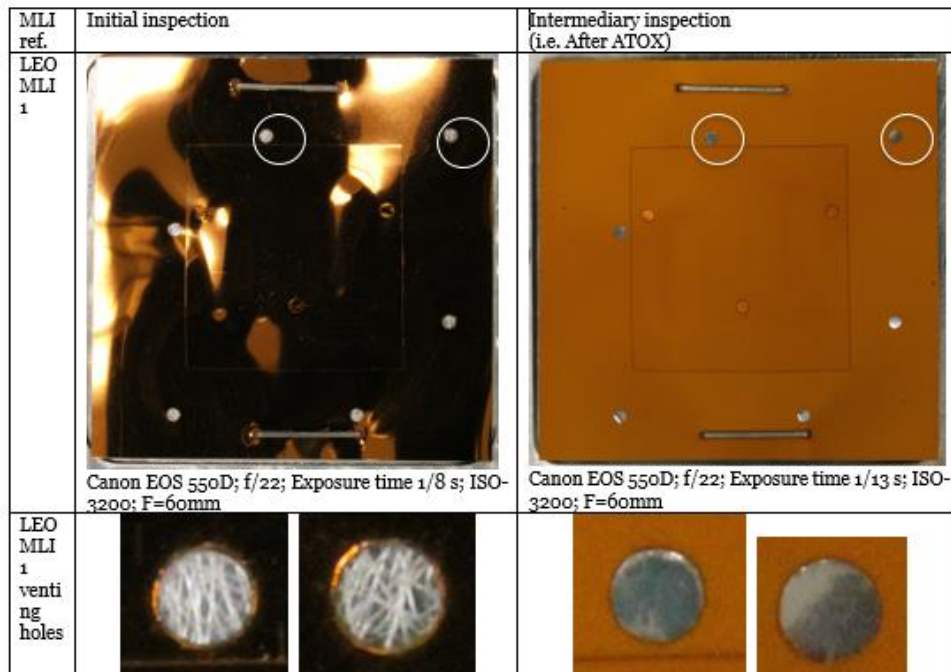
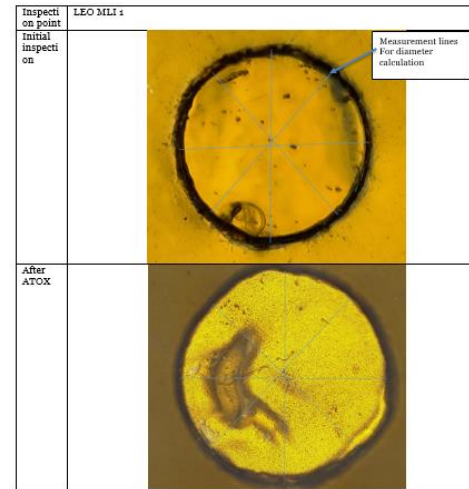
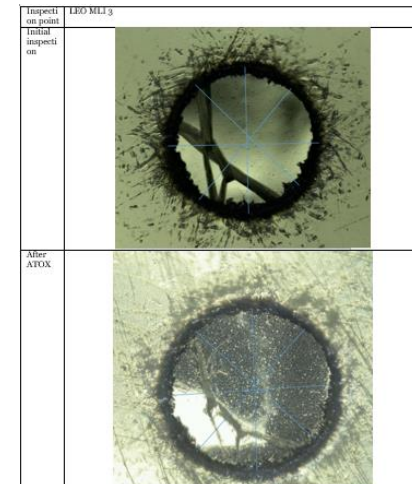
## - MLI 1 After 8.1 Years (800Km orbit)

## - MLI venting Holes

MLIs	Before ATOX [μm]	After ATOX [μm]	Scratch increase
MLI 1	1390	1488	7%
MLI 2	1217	1413	16%
MLI 3	1348	1360	0.8%

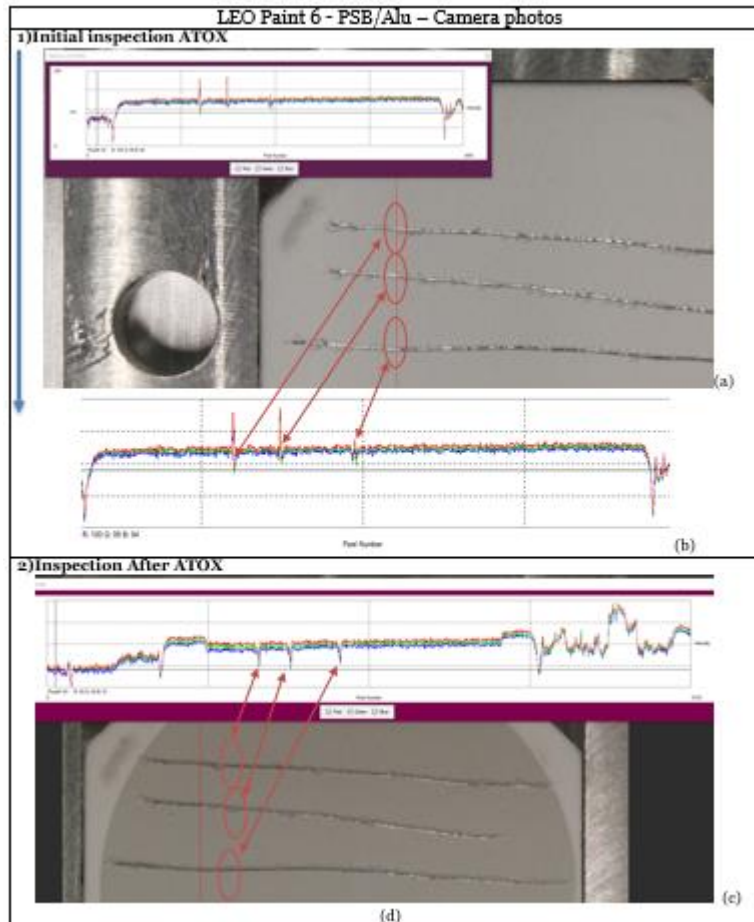
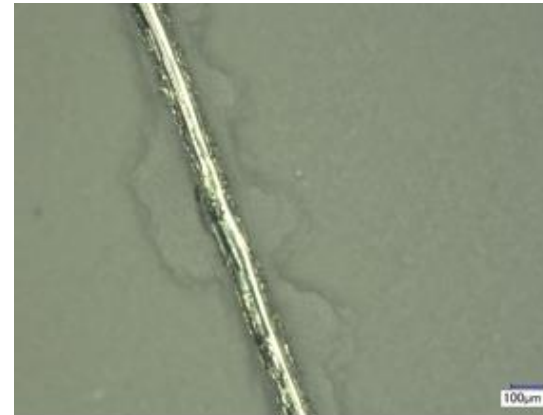
- PSB/Alu (white silicate)

## - Degradation of surfaces and isolating material

- Scratch increased observed in paint 6

Sample	Before ATOX	After ATOX	Scratch increase
Paint 6	scratch 1		
	92.9 [µm] ± 1.9	141.8[µm] ± 3.2	53%
	scratch 2		
	94.7 [µm] ± 2.4	132.2 [µm] ± 2.7	40%
	scratch 3		
	106.8 [µm] ± 2.8	185.1 [µm] ± 4.5	73%

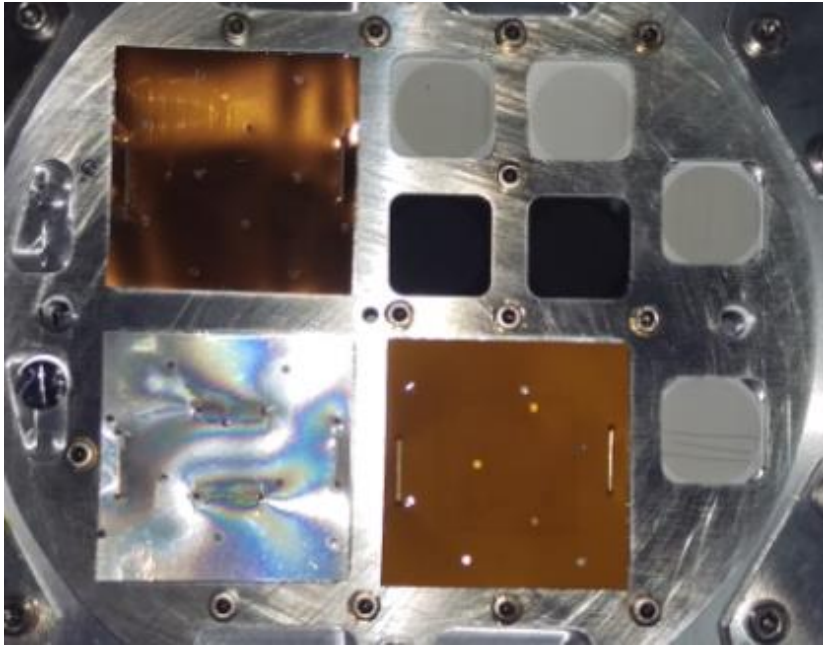
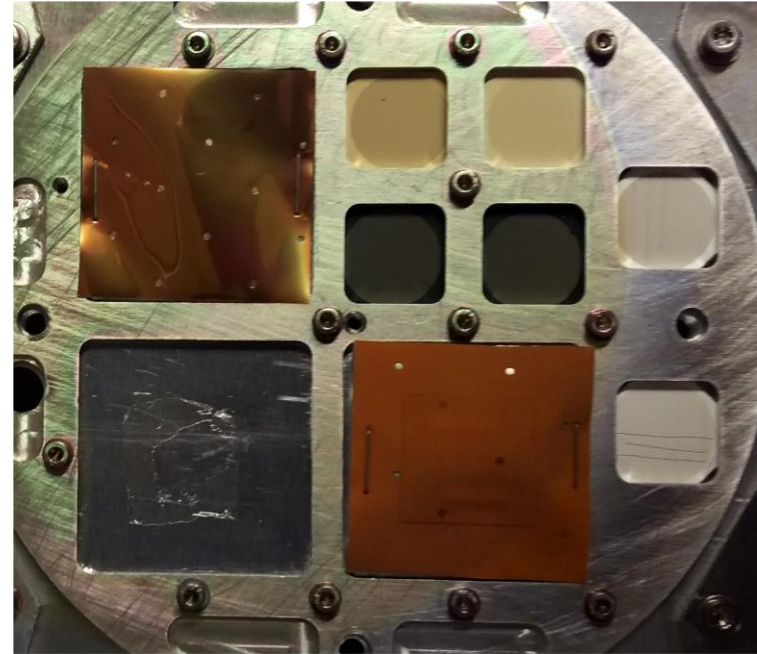
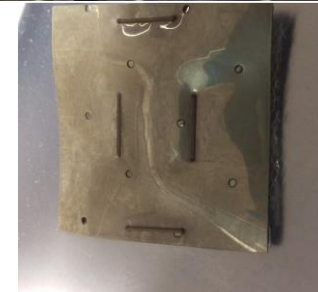
- TVC (500 cycles; +140 to -120); - Average number of suns 2.4 (5145 ESH)

- MLI 2 Fall down during 433 cycles (cooldown)
- MLIs become stiffer/curved
- Darkening/whitening of paints of paints

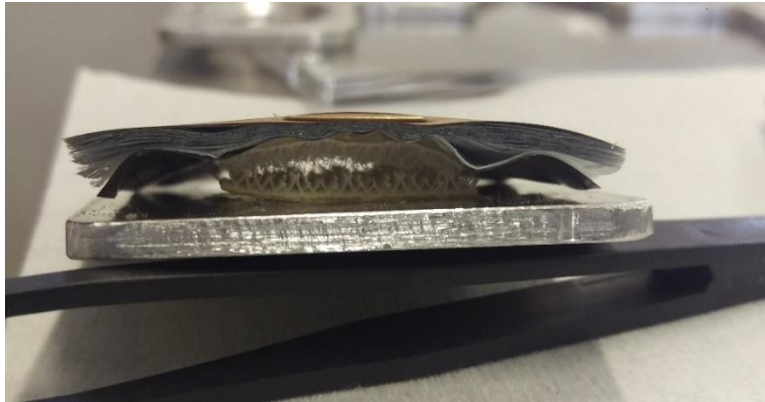
- MLI side view

- MLI becomes stiffer/curved
- Velcro shrinks
- PSA degrades

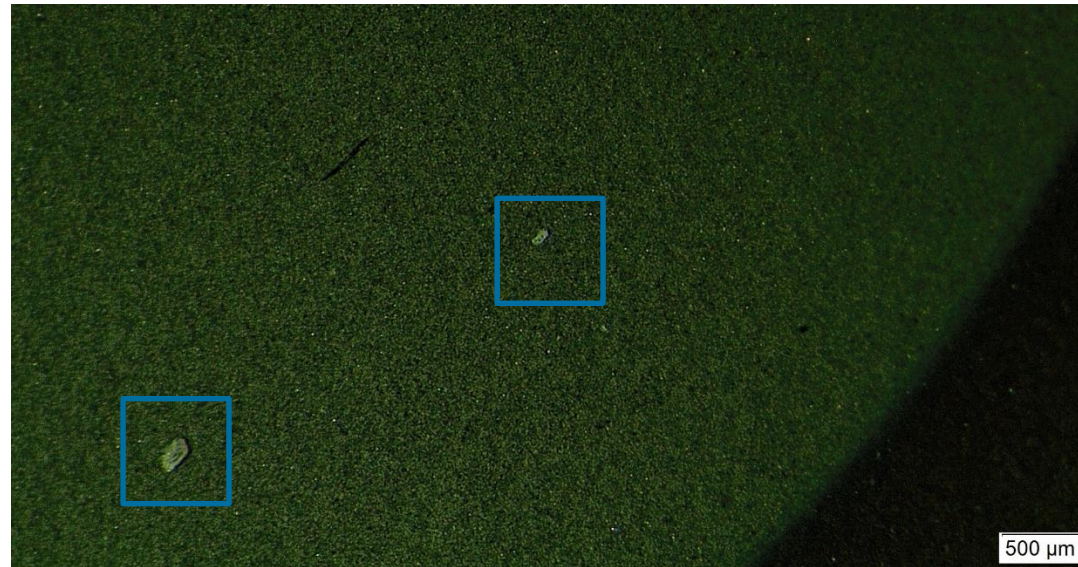
PUK flaking

- Paint flaking observed in PUK and PSB paint

Flaking Area ( $\mu\text{m}^2$ )
1	15000
2	36000
3	18000

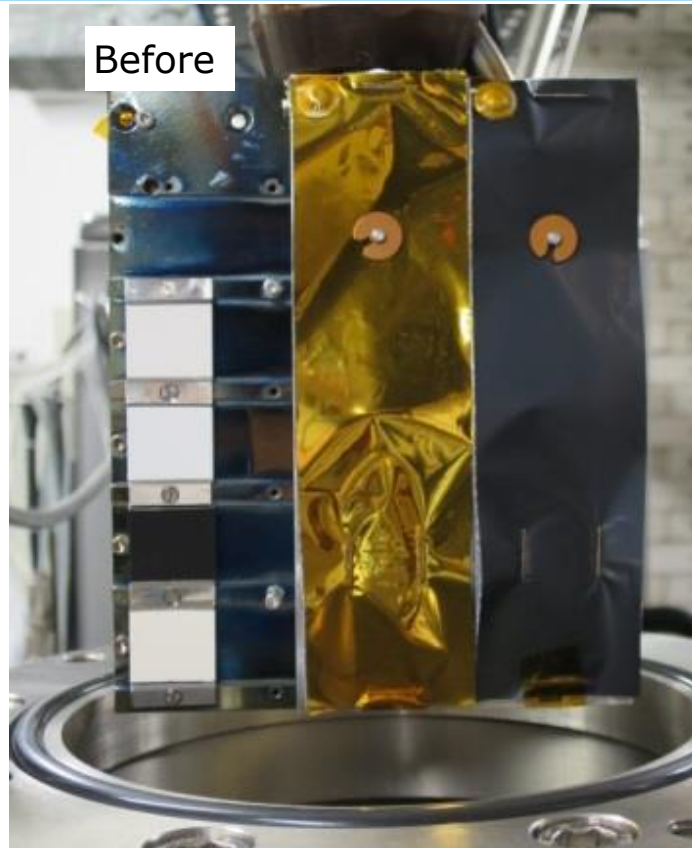
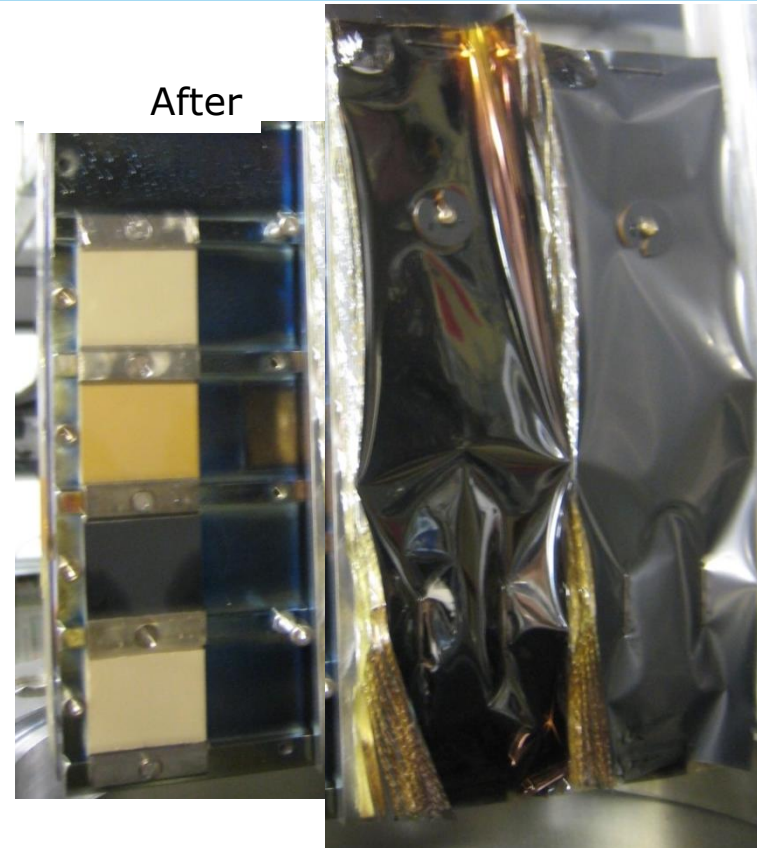
- MLIs: Strong darkening of external kapton layer (solar absorptance almost doubled  $0,35 > 0,68$ ), very slight whitening of black kapton (less degraded), no in situ evidence of mechanical damage (only curling),
- Paintings: discolouring of white paints (solar absorptance x3-5), no-self flaking (no sample fracture even after peeling test)

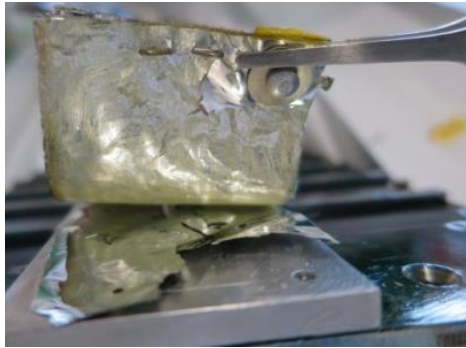
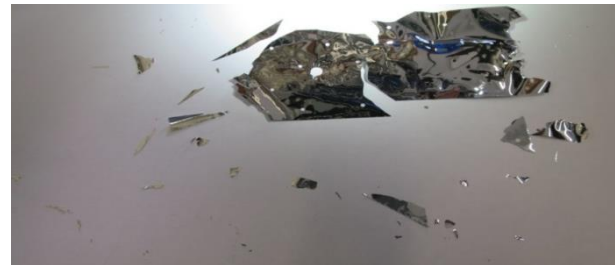
- mylar foils appeared brittle and falling apart (debris generated from handling)
- velcros is discoloured/bended (local mechanical stress at mylar foils) and brittle loops
- Polyester fleece spacers and dacron are OK

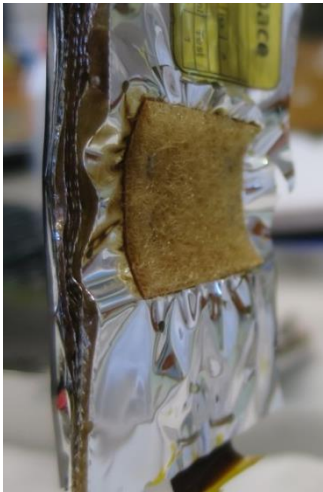
**electrons dose effect  
influence of  $T^\circ (\geq T_v)$   
DSC shows strong degradation with  
partial-to-complete vanishing of  
crystalline content in both materials**

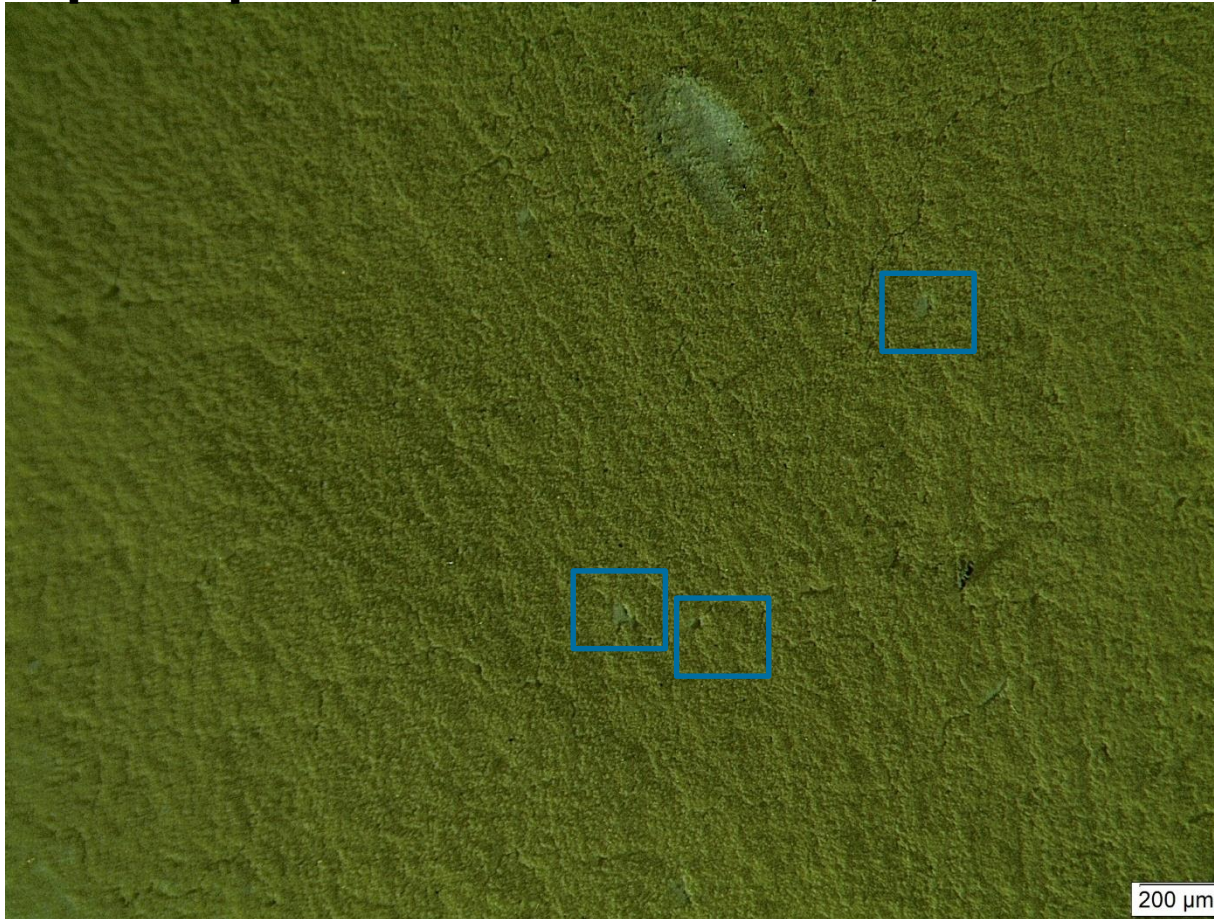
## - Microscope inspection - LEO Paint 1 PSB/CFRP-

Case study #	Probable origin of debris	Particle size
1	PSB	10 µm square
2	PSB	6.25 µm square
16	PSB	4 µm square
21	PSB	6.7 µm square
21	PSB	4.4 µm square
24	PSB	5.4 µm
24	PSB	3.4 µm
24	PSB	2.9 µm
26	PSB	24 µm

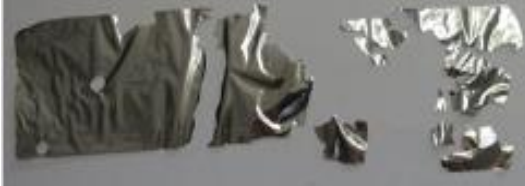
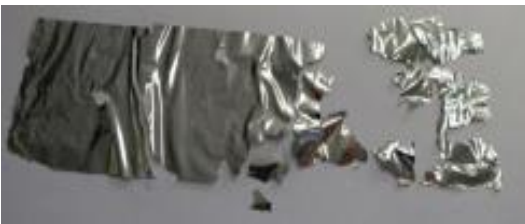
Debris of MLI internal layers

## Observed in GEO material test:

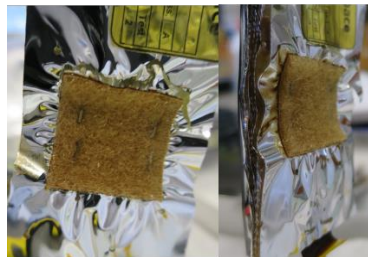
Velcro degradation

- Discover that Velcro's severe degradation
