COMPATIBILITY OF WELDED PROPELLANT SYSTEMS WITH NEW GREEN PROPELLANTS

SAMANTHA GRAHAM PROPULSION ENGINEER EUROPEAN ASTROTECH

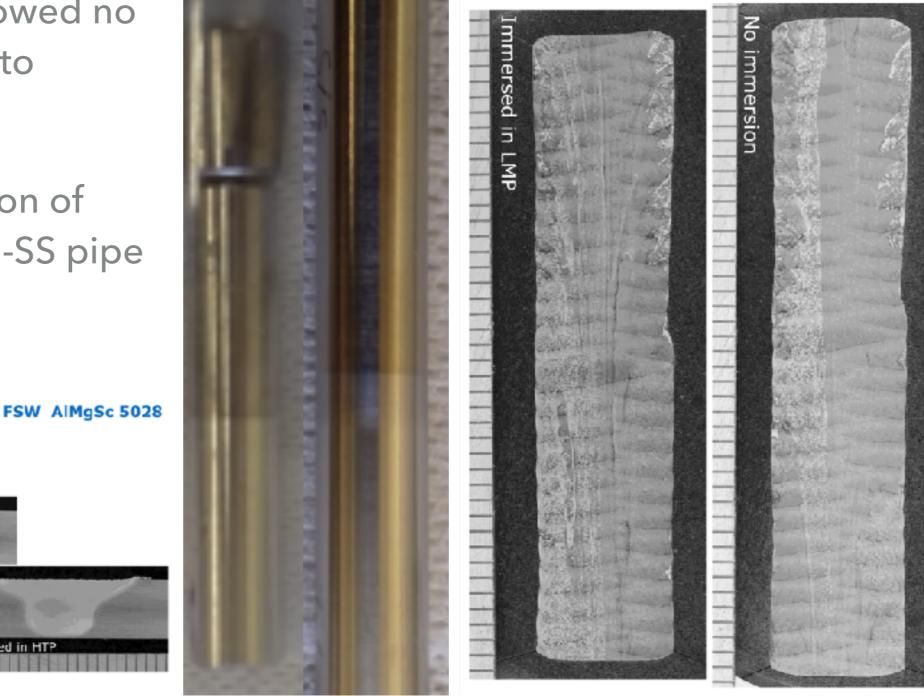
WELD INSPECTION

- Metallography showed no noticeable effects to microstructure
- Some discolouration of stainless steel in Ti-SS pipe transition joint

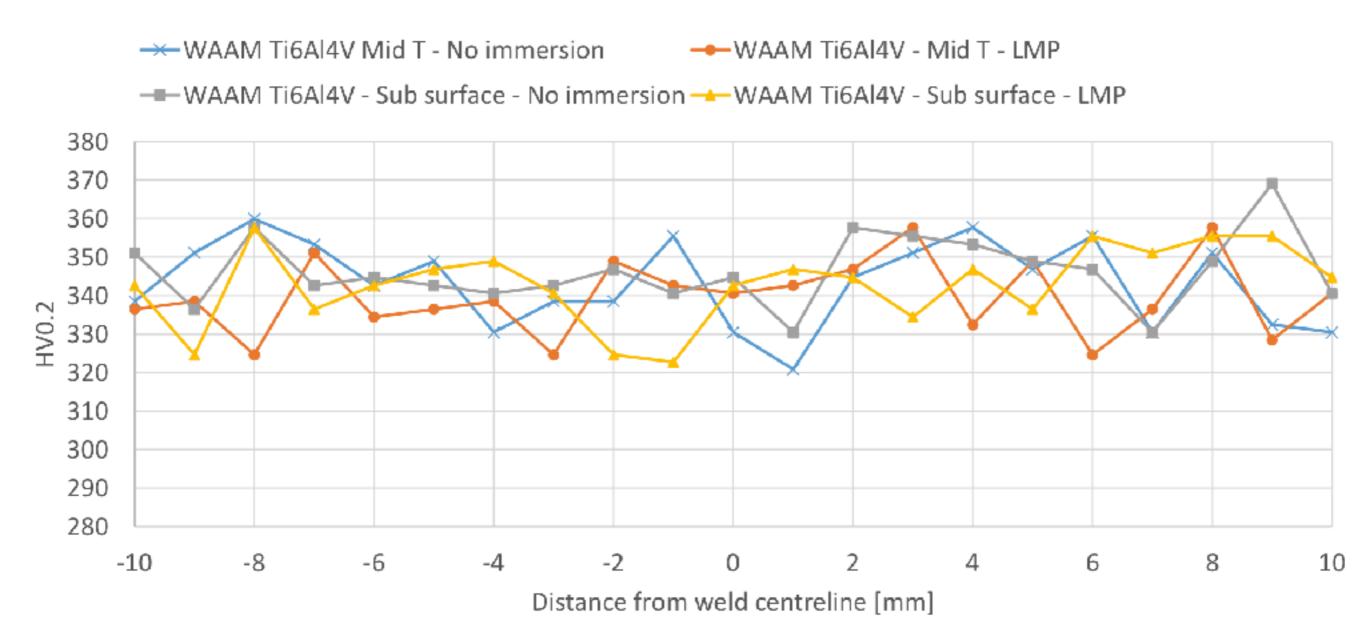
HARDNESS TESTING

• No obvious effect of environmental condition on sample hardness

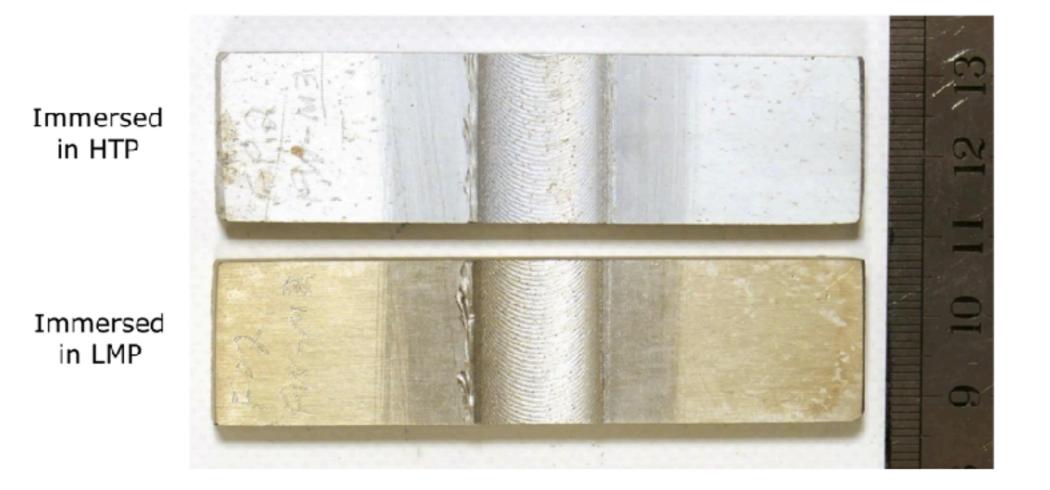
OTHER MATERIALS TESTING

- No mass change indicates no observable corrosion
- No problems during **burst tests** @ 4 x MEOP

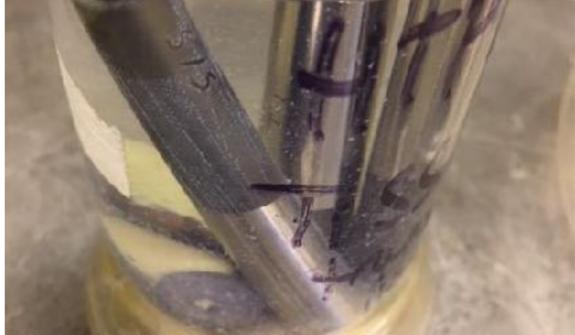
Al2060 samples immediately after immersion

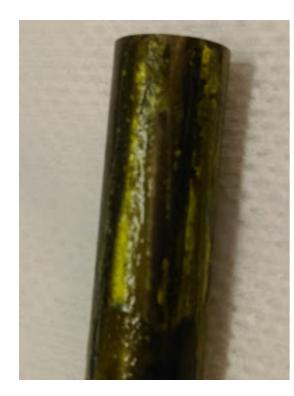
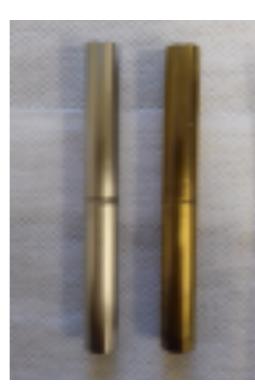
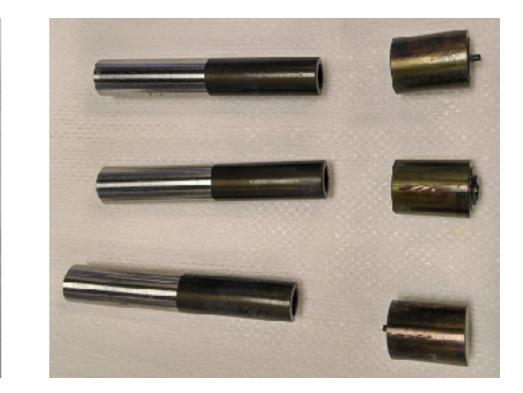
- Mass changes consistent with ICP analysis
- No problems during **burst tests** @ 4 x MEOP
- Weld inspection showed discolouration but no structural defects in the weld joint or parent material
