SPARTAN 6 Evaluation for Space Application

16th March 2016

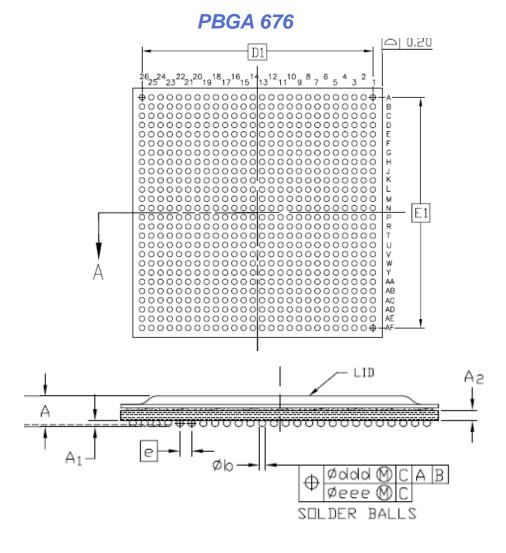
Description of Spartan6 package

Characteristics	PBGA 676
Type of package	plastic
matrix	26 x 26
Dimensions (mm)	27 x 27
Pitch (mm)	1
Interconnection	solderballs 600 Sn63Pb37

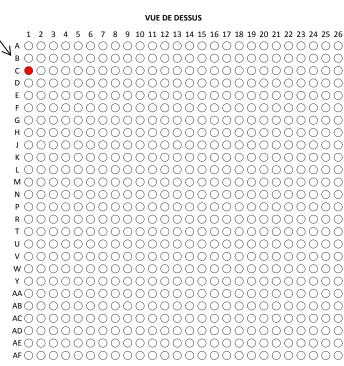
Side view of PBGA 676 mounted on polyimid board

- Results through environmental tests
- After vibration and shocks
 - 4 /5 assembled PBGA passed successfully vibration and shocks
 - 1 assembled PBGA presented one open circuit which was detected on one external solderball => this board was kept apart

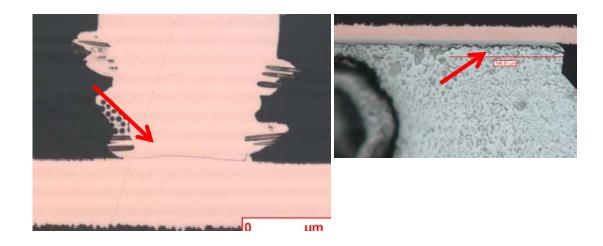
- Microsection revealed after 500 cycles:
 - thin cracks on top of solderballs => no impact on electrical continuity
 - Severe cracks in microvias of printed circuit board
 - Confirmed on board only submitted to vibration and shocks

Microsection of board n°3 after shocks : crack in microvia

Microsection of board n°4 after 500 cycles: crack in microvia and thin crack at solderball level

- 6 PBGA676 were assembled on HDI board using standard automatic assembly process at Airbus DS Elancourt.
- Boards were submitted to vibration, shocks and thermal cycles.
- Except one assembled PBGA, all boards passed successfully mechanical tests.
- ☐ Electrical failures were detected earlier on PBGA assemblies
- Investigations highlighted significant cracks in PCB microvias.
 - PCB manufacturer improved its process manufacturing and delivered new printed circuit boards with successful IST test results.
 - New assembly evaluation is on going with reliable PCB.
