# Highly Reliable System-on-Chip using Dynamical Reconfigurable FPGAs

Luca Boragno  
Boyang Du  
Luca Sterpone

Politecnico di Torino CAD Group - Dipartimento di Automatica e Informatica  
Torino - Italy

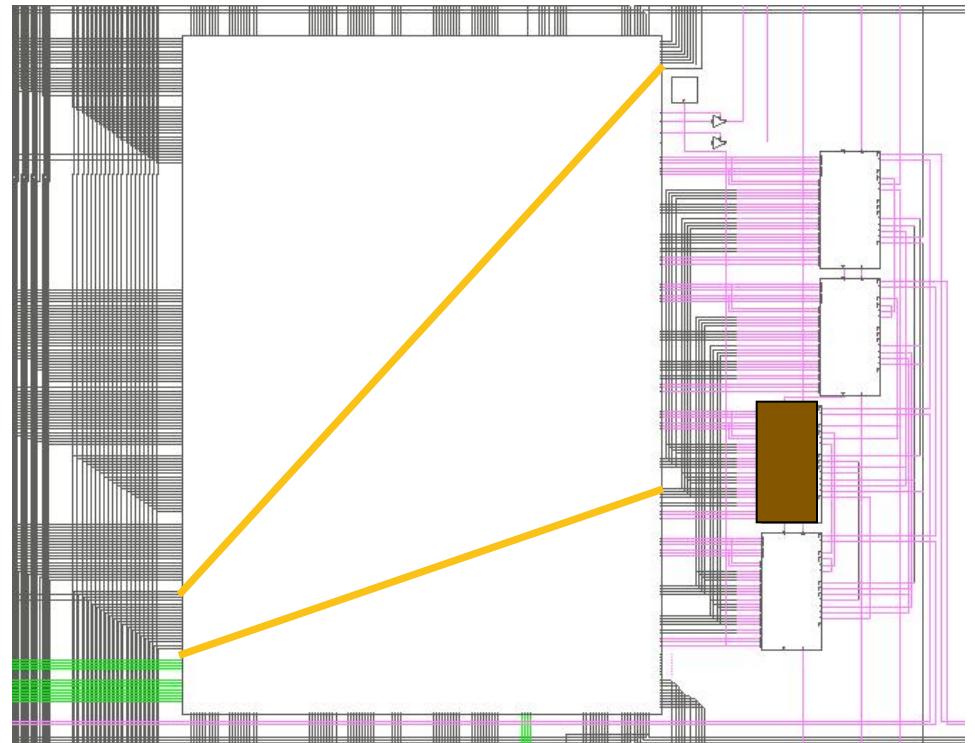
- The bitstream

0	1	0	0	0	0
1	0	0	0	0	0
1	1	0	0	0	0
0	0	0	0	1	0
0	1	0	1	0	0
0	0	0	0	0	0

- The original netlist

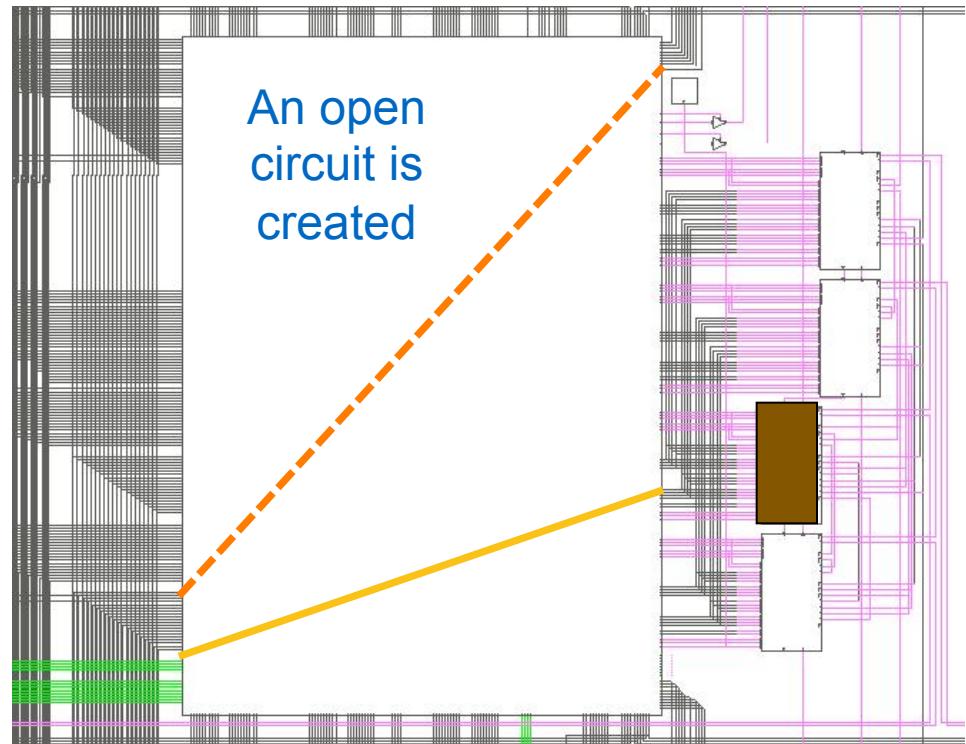
1→0

0	1	0	0	0	0
*	0	0	0	0	0
1	1	0	0	0	0
0	0	0	0	1	0
0	1	0	1	0	0
0	0	0	0	0	0

- The corrupted netlist

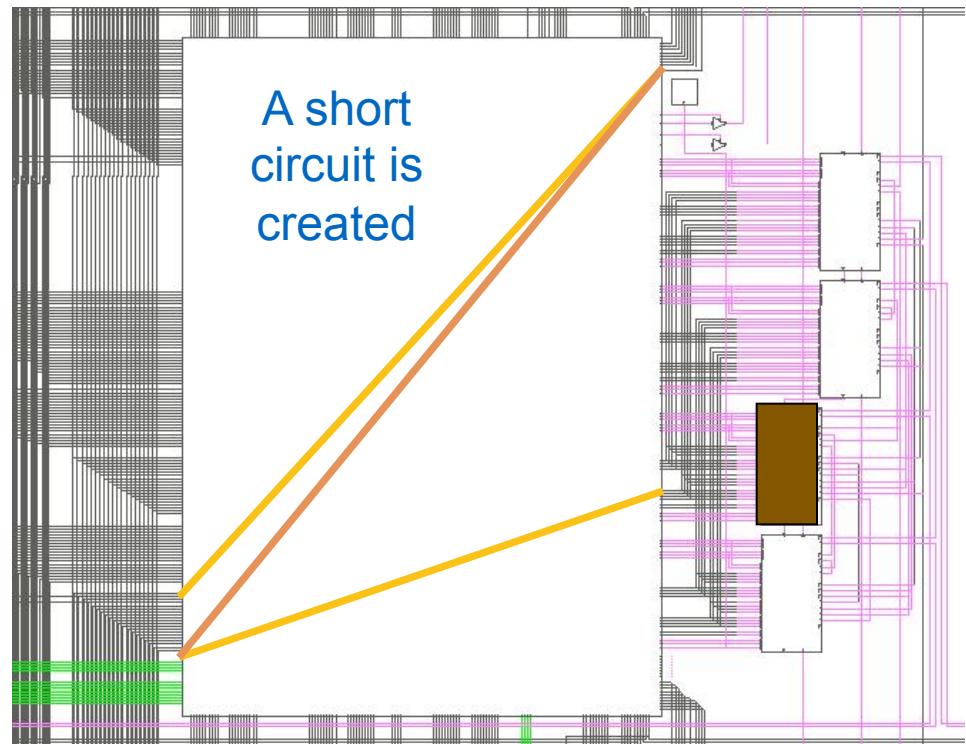
0→1

0	1	0	0	0	0	0
1	0	*	0	0	0	0
1	1	0	0	0	0	0
0	0	0	0	1	0	0
0	1	0	1	0	0	0
0	0	0	0	0	0	0

- The corrupted netlist

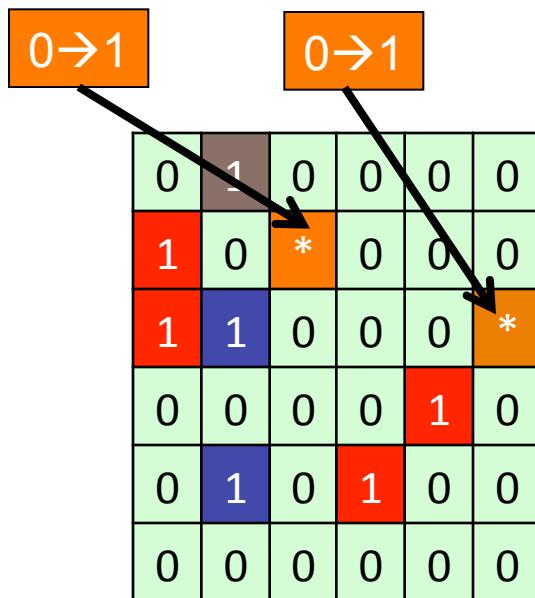
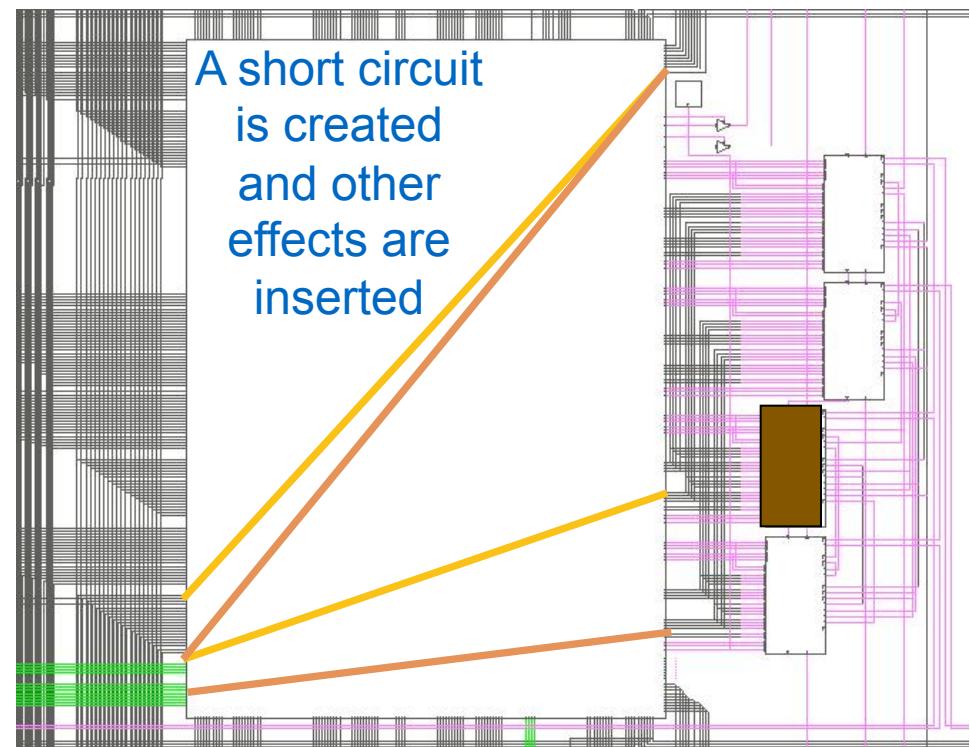
# SEU scenario: accumulation of 2-bit

## □ The bitstream

## □ The corrupted netlist

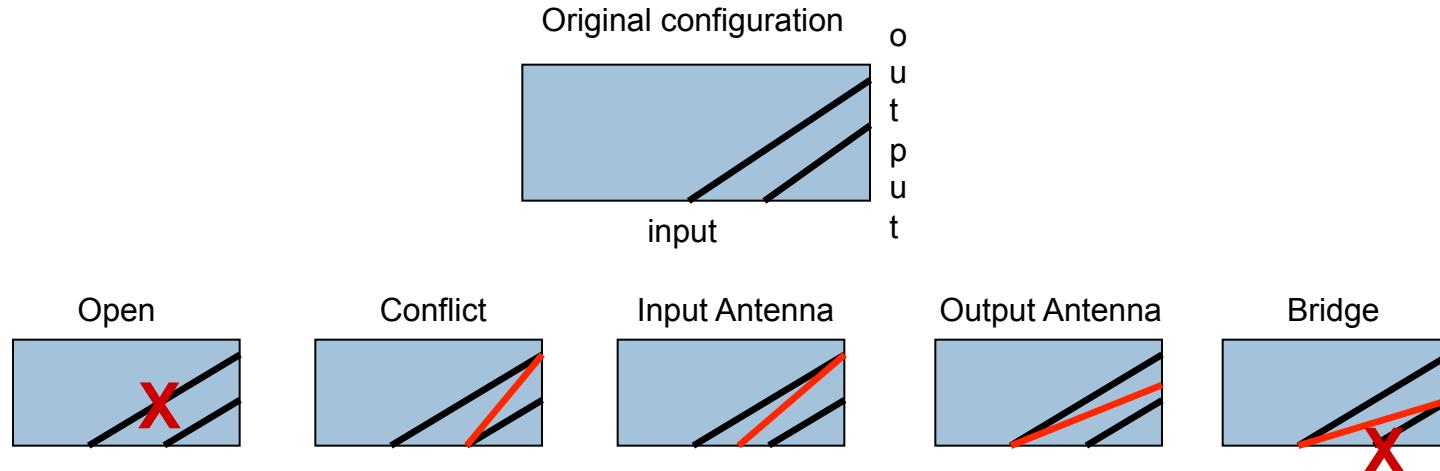
- SEU within the configuration memory
  - FPGA resource not affected : **NO ERROR**
  - FPGA resource affected : **ERROR**
- SEU induced architectural modification
  - **Logic Element: LUT, MUX, FF Config**
  - **Interconnections: Switchbox**

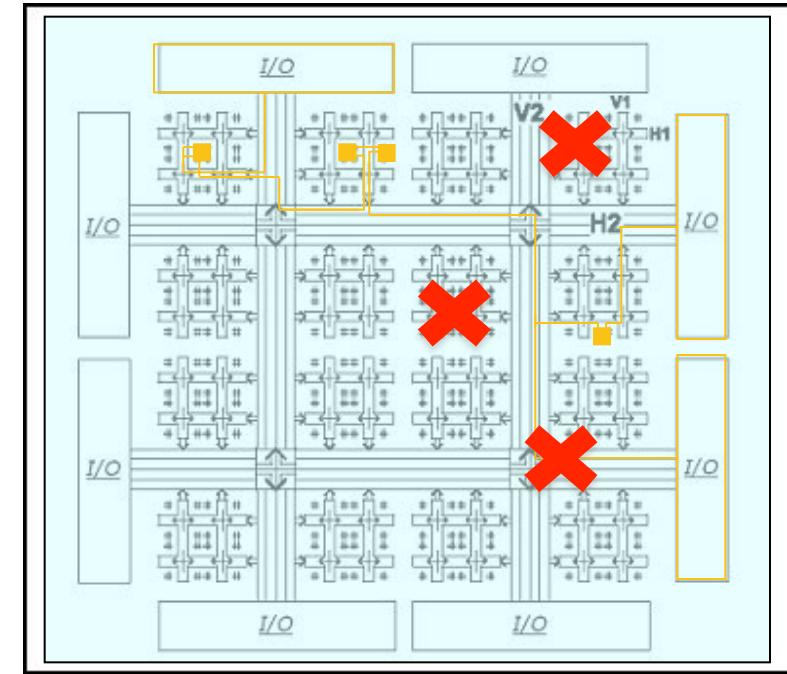
SEU effect: No error

**SEU effect: Error**

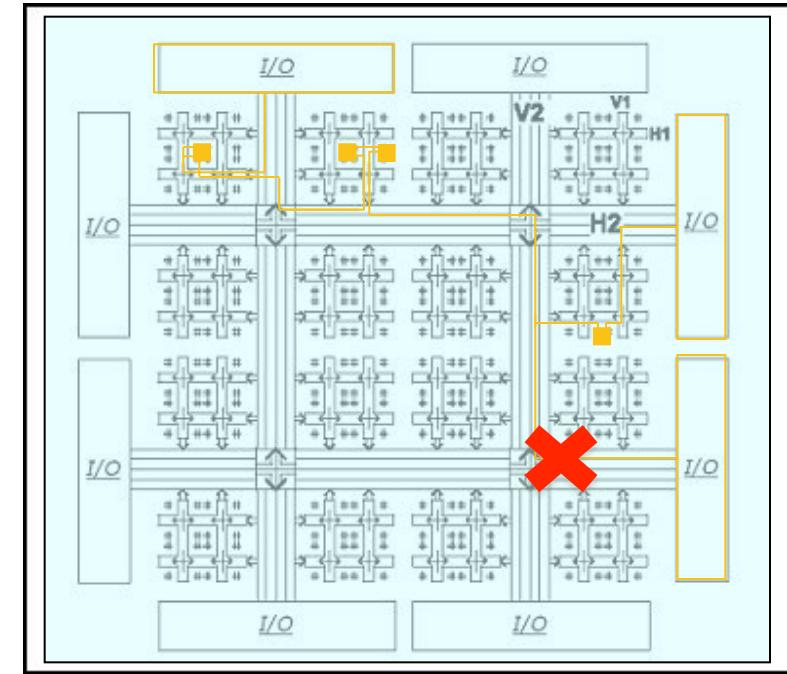
Execution time    SEU effect    Scrub cycle

**SEU effect: Error**

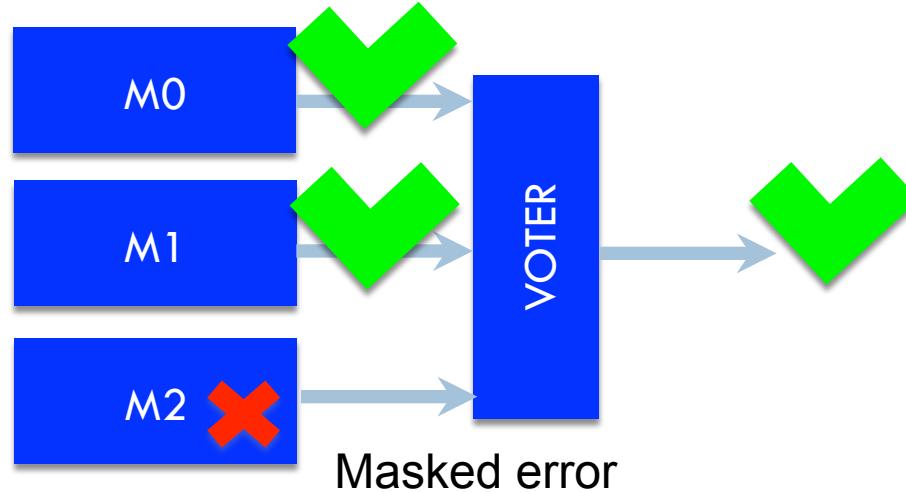
## TMR

- The application of Netlist-based TMR and scrubbing is an effective solution
  - Drawbacks: power consumption and functional availability

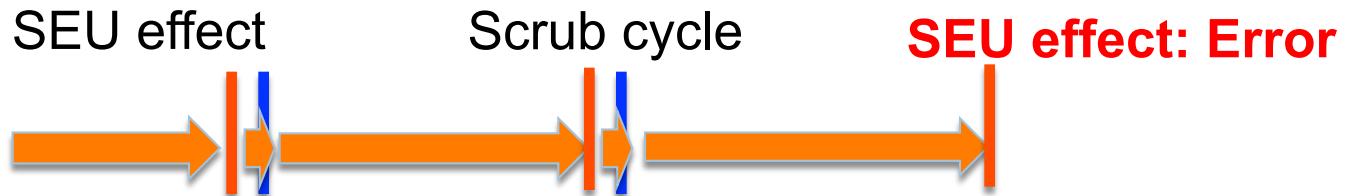
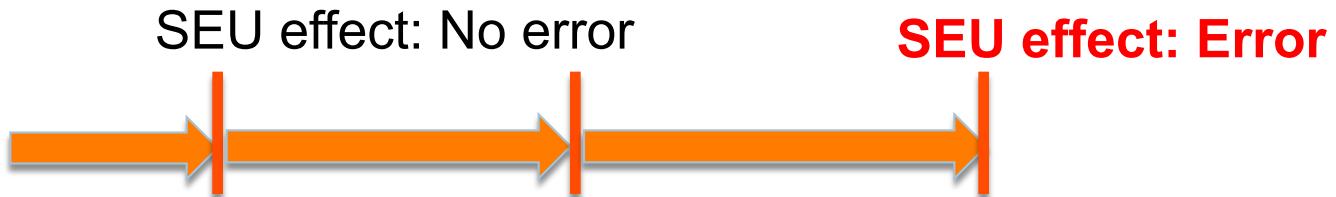
**with  
scrubbing**

**without  
scrubbing**

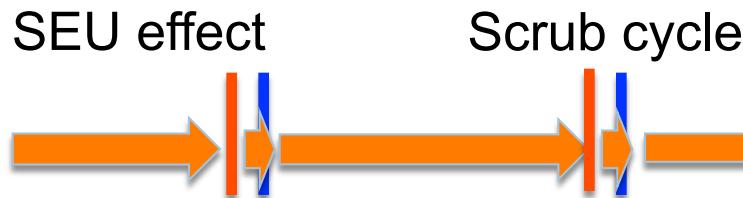
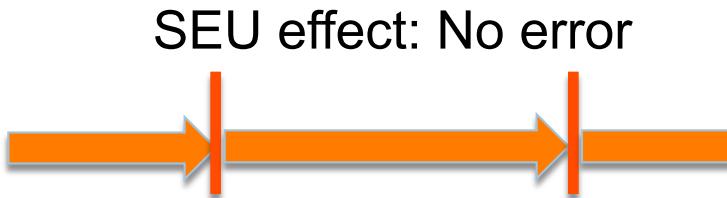
with  
scrubbing

**SEU effect: Error**

without  
scrubbing

Errors affecting the circuit outputs happen at the same time

- **Probability of SEU location**
- Avoid of SPF: **TMR is a MUST**

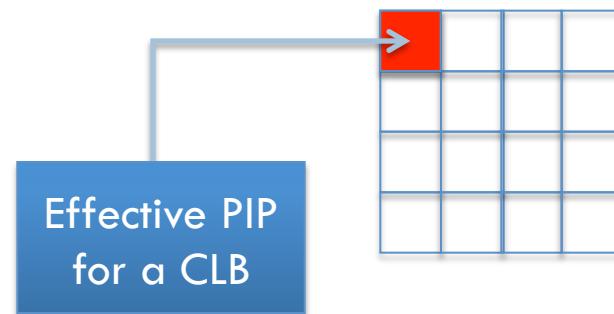
Device Name	Effective PIPs [#]	Decoding [days]
XC5VLX50T-FF1136	15,695	≈6.5
XC7K70E-2FBG676	21,081	≈8.6
XC7K325T-2FBG900	21,081	≈12.3

- The decoding is performed on effective PIPs
- The whole PIP coding is generated calculating the configuration memory offset between different CLBs

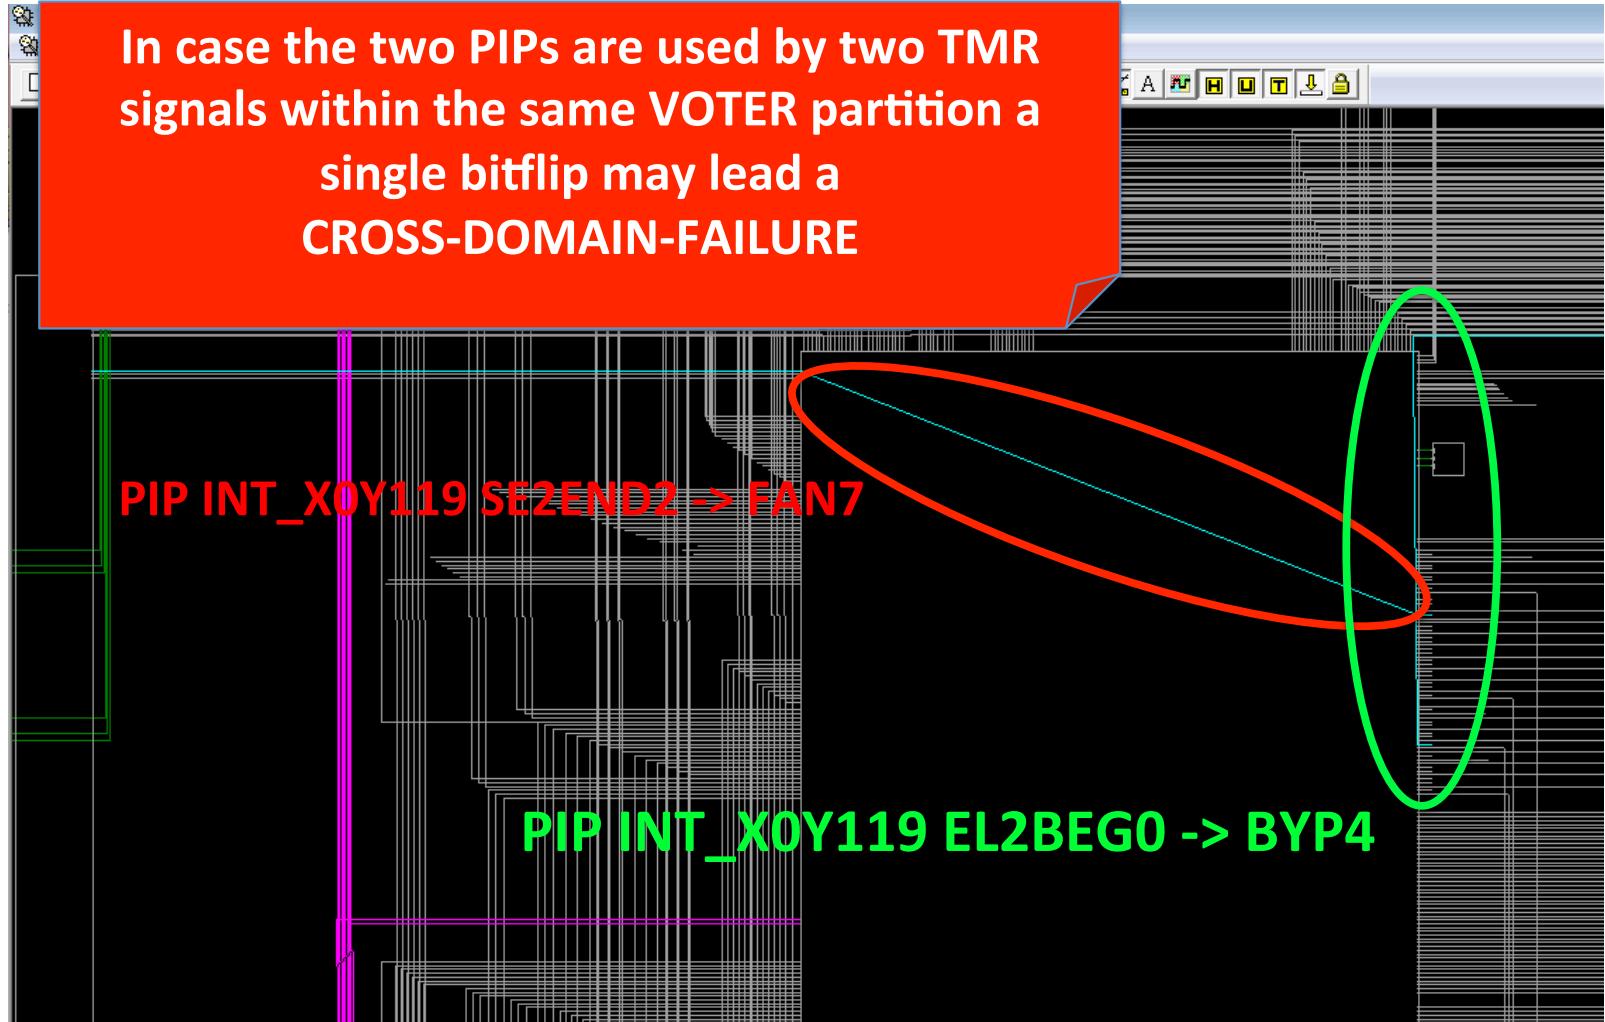
In case the two PIPs are used by two TMR signals within the same VOTER partition a single bitflip may lead a CROSS-DOMAIN-FAILURE

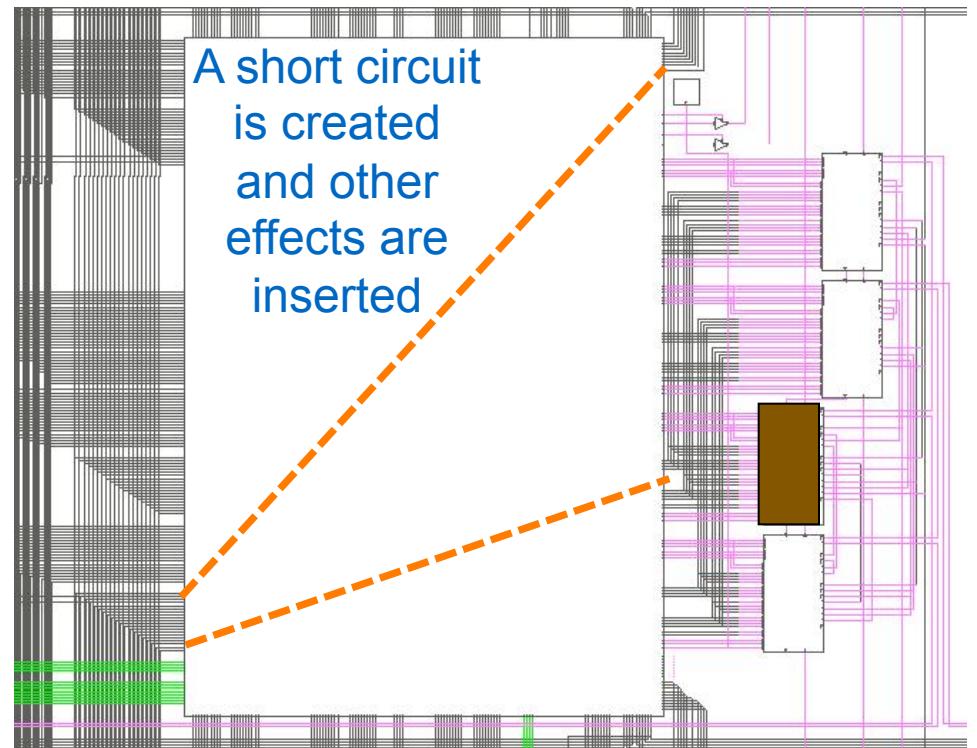
# 1-bit controlling multiple PIPs

1→0						
0	1	0	0	0	0	0
1	0	*	0	0	0	0
1	1	0	0	0	0	0
0	0	0	0	1	0	0
0	1	0	1	0	0	0
0	0	0	0	0	0	0

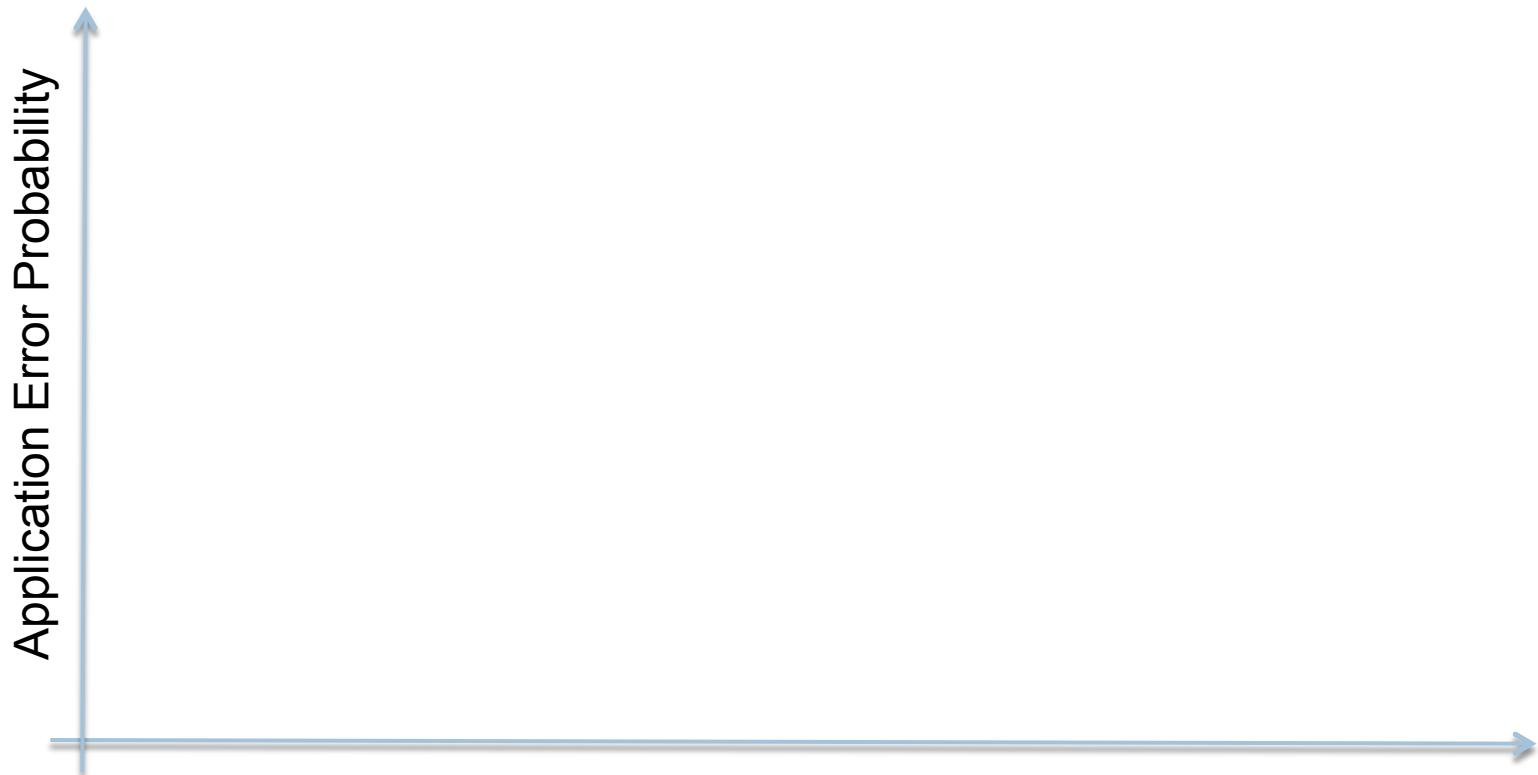
## □ Calculation of the Application Error Probability

Progressive accumulation of bitflips (SEUs)

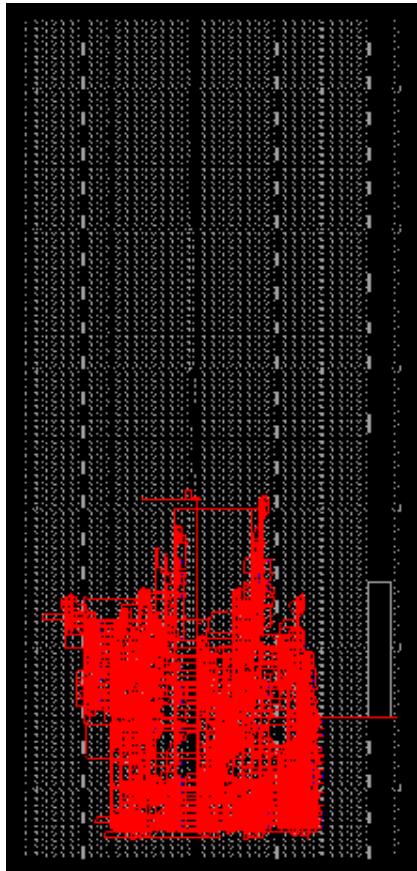
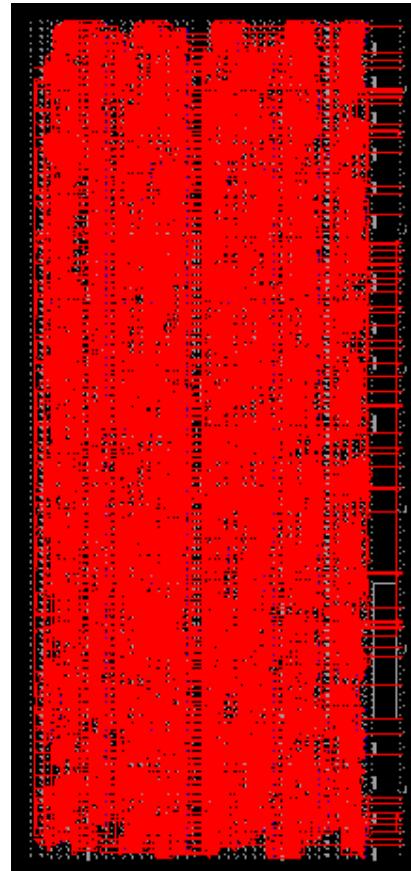
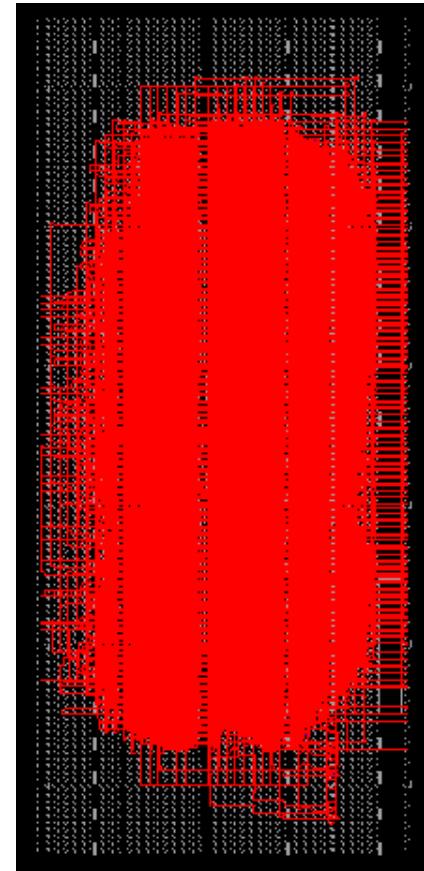
**B13x30 - PLAIN**

**B13x30 - XTMR**

**B13x30 – VP-XTMR**

- 3 different design topologies have been tested at Los Alamos
  - **PLAIN** : b13x30 without any type of hardening
  - **XTMR**: Triple Modular Redundancy version with converge option of outputs pins using Xilinx TMRTTool 2.1.76
  - **VP-XTMR**: Hardening version of XTMR with re-placement constraints generated byVERI-Place tool.

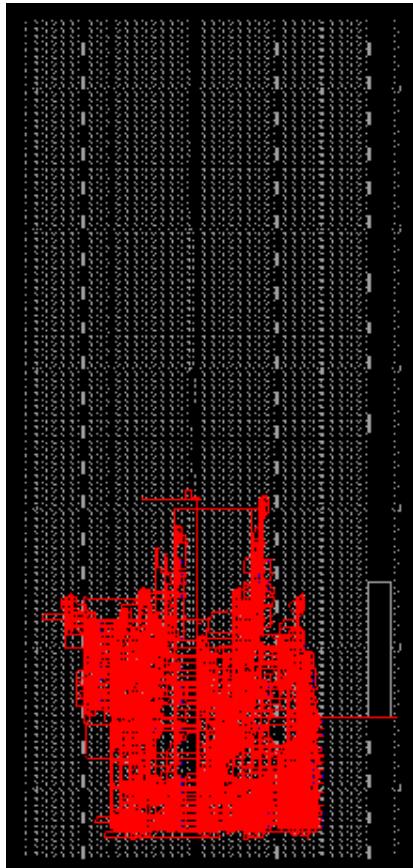
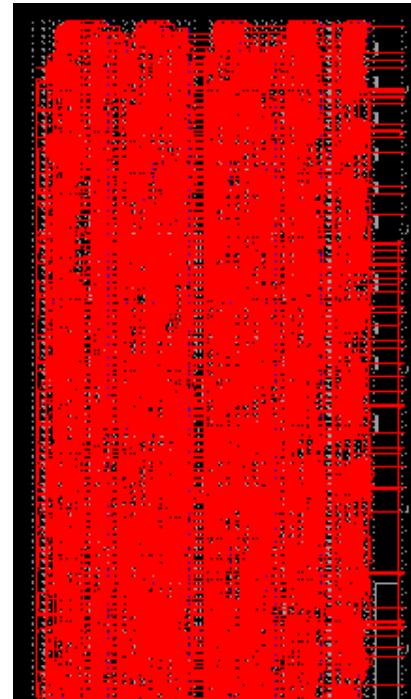
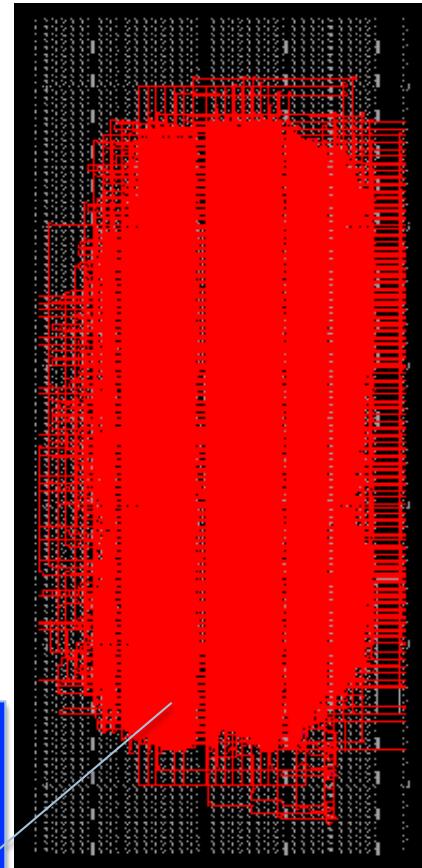
**B13x30 - PLAIN**

**B13x30 - XTMR**

**B13x30 – VP-XTMR**

The Layout is complementary  
with Isolation Design Flow
