Space Debris Research at DLR

SOLID-A solar panel based impact detector

DLR Institute of Space Systems Bremen, Germany

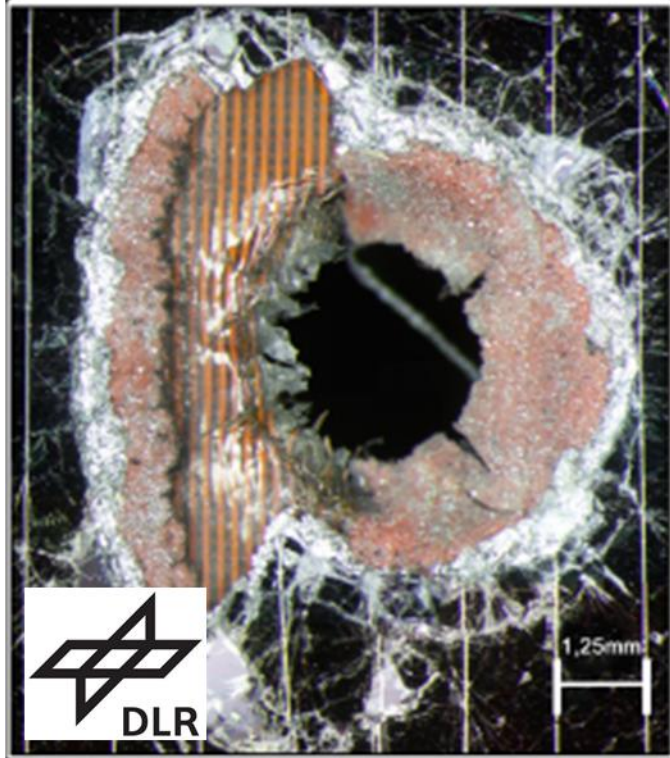
HVI Damages on SOLID Detector

Al 2017
 $\varnothing \sim 1.5 \text{ mm}$
 $v_p \sim 5 \text{ km/s}$

Glass,
 $\varnothing \sim 500 \mu\text{m}$,
 $v_p \sim 4 \text{ km/s}$

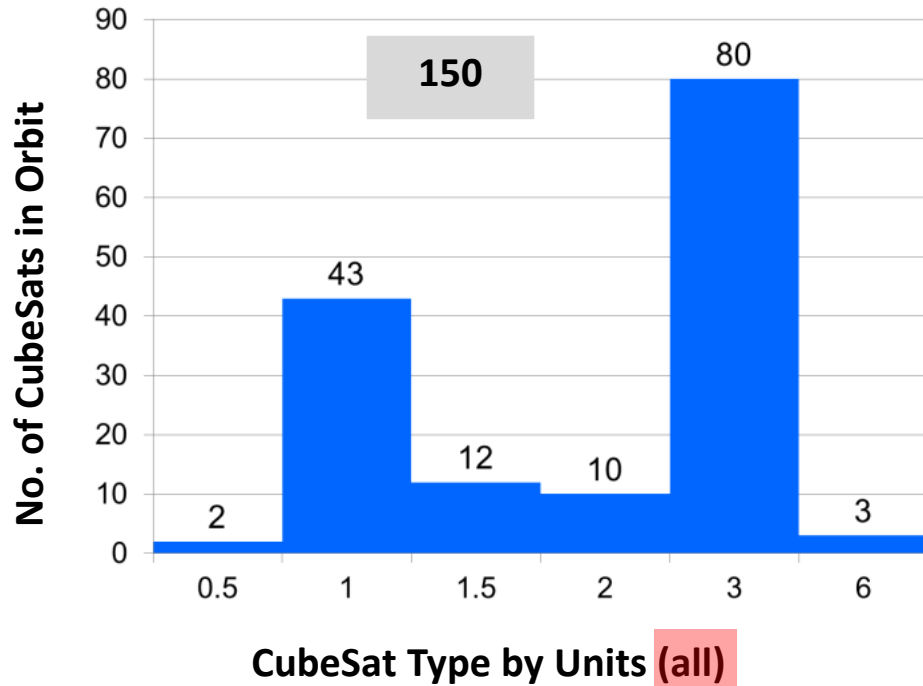
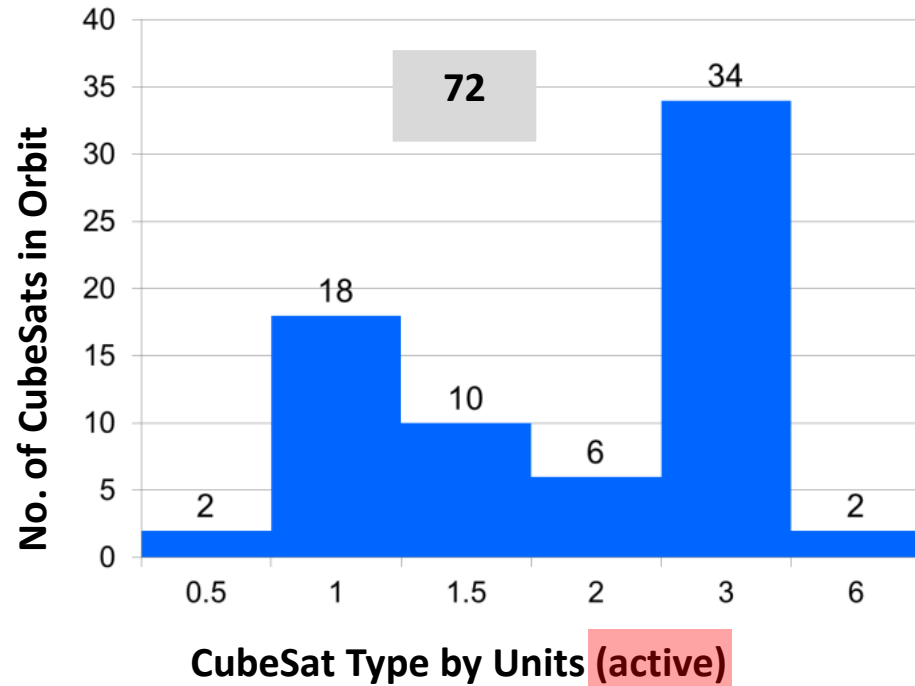
Detection Area estimation (w/o demised, April 2016)

Currently available total solar panel area of active CubeSats in orbits ca. **6.1 m²** !

Estimated total detection area of active CubeSats is 6.1 m²

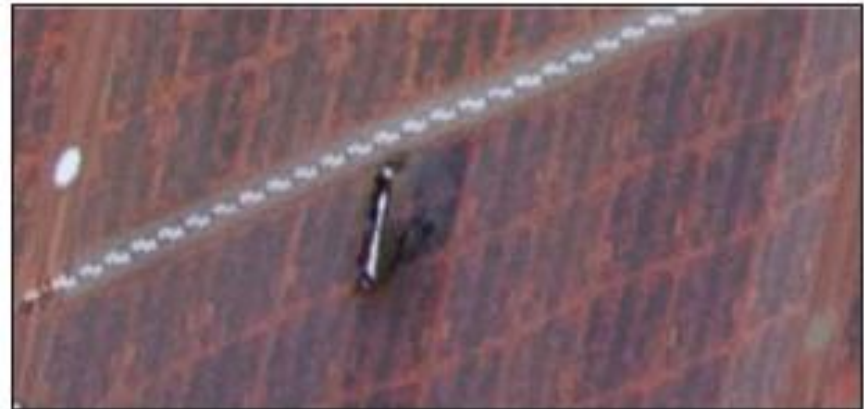
Damage Examples on ISS Solar Panels

Figure 0. ISS Solar Array 2A, panel 00 damage.
