# Test Results on SDRAM IS42S86400B-7TLI

Thierry BONNOIT **Maximilien GLORIEUX** Cesar BOATELLA POLO

29 June 2023

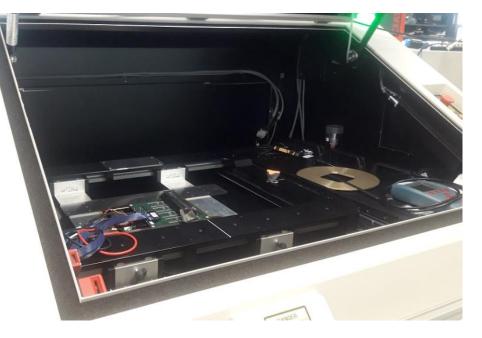
#### • CNES Laser Facility characteristics:

- Single photon absorption
- Wavelength: 1064nm
- Pulse energy: up to 2.5nJ per pulse
- Pulse picket to reduce pulse frequency
- Pulse duration: 7.5ps
- 1X to 50X lens
  - Range: 13x13 mm to 250x250 µm
  - Resolution: 22µm to 0.9µm

#### • Dynamic test algorithm with flexible options:

- Operation order
- Data pattern
- Address sequence

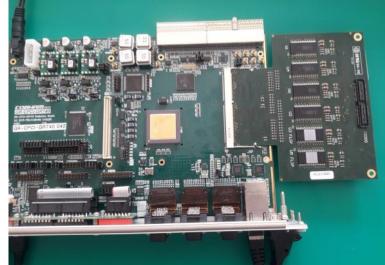
#### System HI Tests with GR740 LEON4

- ISSI as main memory of GR740 LEON4
  - Assess EDAC capability to detect/correct SEFIs
  - 2 devices irradiated simultaneously
- GR740 EDACs are based on 4 bits nibbles
  - 1 nibble error can be corrected
  - Bus data width: 64 or 32 bits (data wrote on 2 consecutive address)
  - 2 interleaving scheme:
    - Mode A: 4 group of 16 bits
    - Mode B: 2 group of 32 bits
  - Test performed in mode A 32 bits
