Markers
Supporting
Navigation

MSN
Development &
Qualification

Ref.: MSN.PRE.ADM.125

Clean Space Industry Days, ESTEC

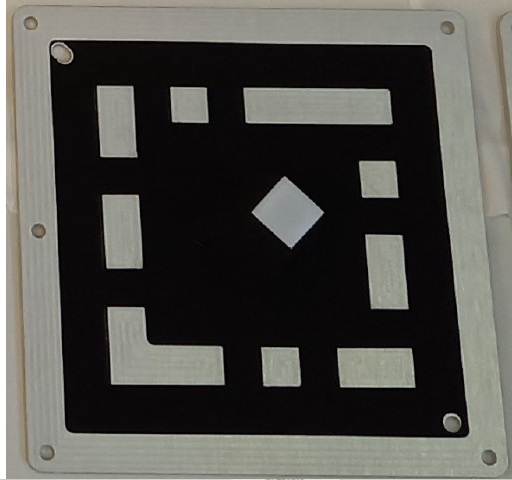
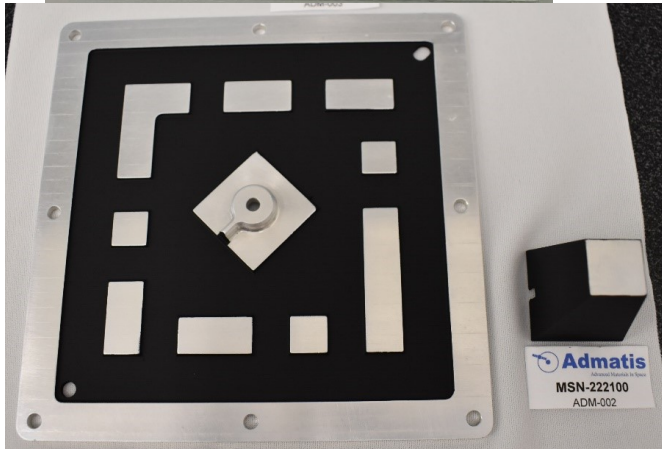
3D Marker

- two-piece construction of a 150×150mm EN AW6082 T6 aluminium base plate with 3mm thickness and a pyramidal element with 40mm height attached to the base plate by an MJ4×10 LN29950 Ti6Al4V screw
- bore and slot for adjustment (dowel) pins
- Alignment with Ø5mm dowel pins
- Coating: Surtec 650 + PNC
- Attachment to SC: 5pcs of MJ4×15 LN29950 Ti6Al4V screws + M4 NFL 23112 Nuflon-coated SS countersunk washers.
- Mass:0.213kg; using 20% mass margin for screws and washers: 0.25kg
- Grounding is implemented by the interface screws.
- coatings are Surtec 650 and a black paint PNC giving contrast in the VNIR and TIR spectra for detection

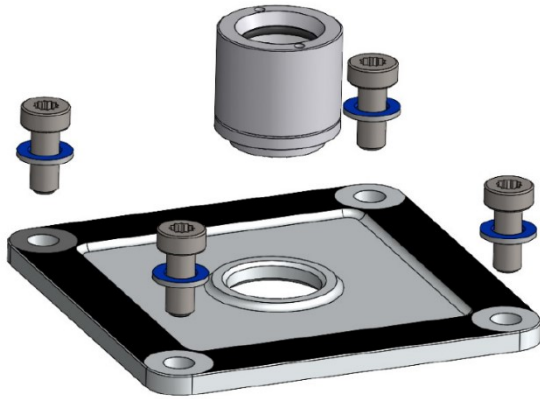
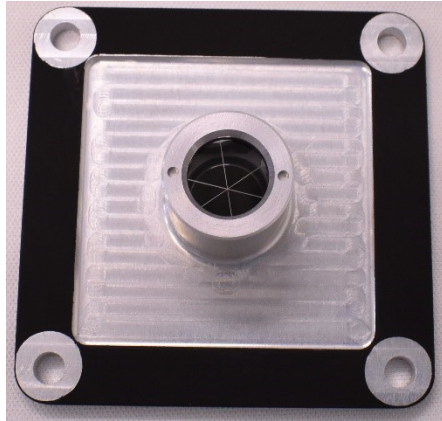
2D Marker

- construction of a 60×60mm baseplate EN AW6082 T6 aluminium with 3mm thickness and an LRR unit with 15.2mm height and $\varnothing 17.8$ screwed to the base plate by $\varnothing 0.535$ "-40TPI optical thread
- Coating: Surtec 650 + PNC
- Attachment to SC: 4pcs of MJ4×10 LN29950 Ti6Al4V screws + M4 NFL 23112 Nuflon-coated SS countersunk washers.
- Mass:0.035kg; using 20% mass margin for screws and washers
- Grounding is implemented by the interface screws.

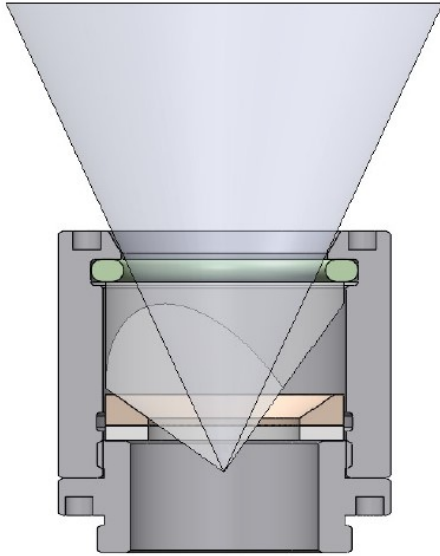
QM

- EN AW6082 T6 aluminium housing
- groove at the upper part to hold the FKM O-ring that gives an elastic support for the CCR.
- CCR is a $\varnothing 12.7\text{mm}$ Aluminum Coated, Fused Silica Corner Cube manufactured and supplied by Edmund Optics
- CCR is supported by a PEEK supporting ring and PTFE adjustment shim is placed to reduce friction.
- Parts are fixed by an EN AW6082 T6 aluminium retaining ring.
- For CRISTAL, the height of the Tube is increased from 13.2 mm to 15.5 mm to make reflected beam intensity to zero at incidence angles higher than ± 25 deg.

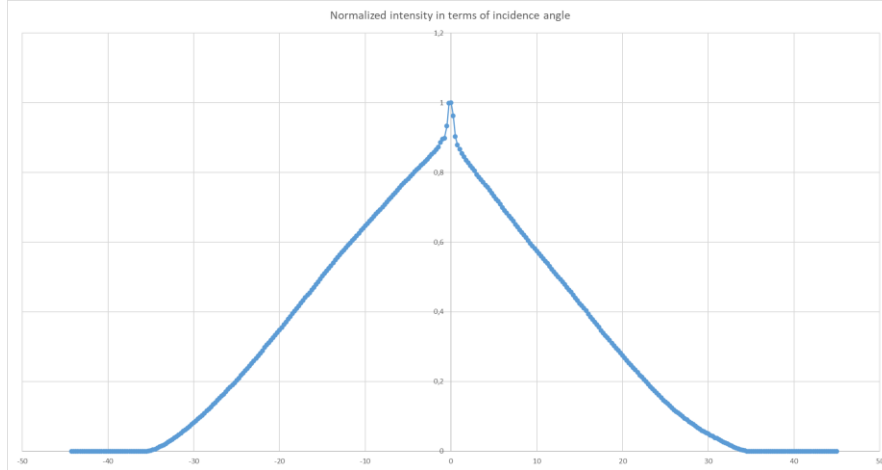
QM

FOV measurement on LRR units

Reflected beam intensity is below 20% at +/- 25 deg.

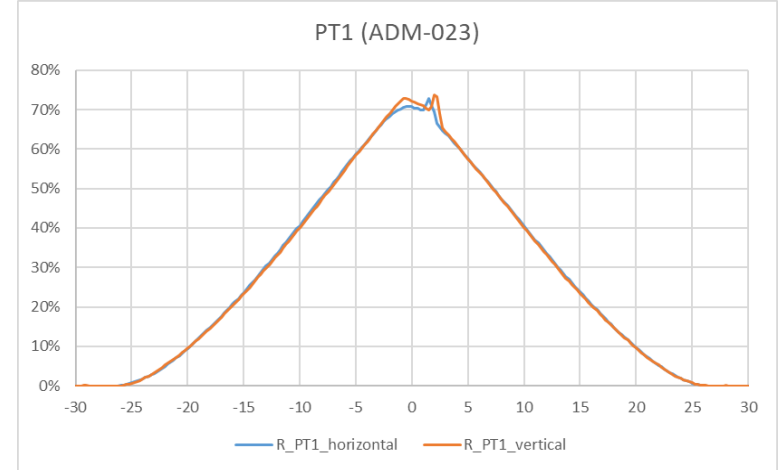
PT for CRISTAL

Reflected beam intensity is below 1% at +/- 25 deg.

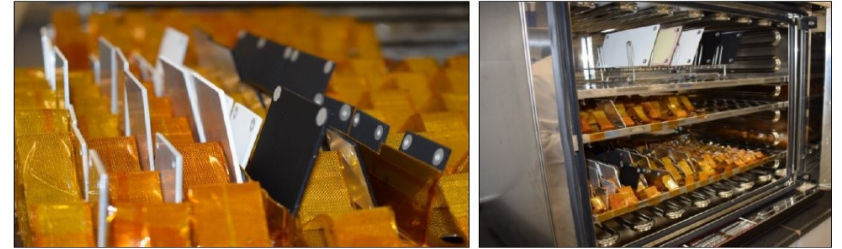
Bake out & pre-screen TVAC

Vacuum level:	min. 5E-6 mbar,
Bakeout temperature:	80°C
Duration:	minimum 72 hours,
TVAC temp. / cycles:	-60 °C / +120 °C / 8

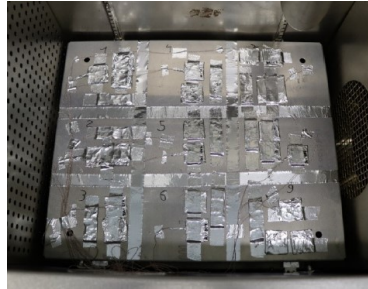
TEST SEQUENCE & LEVELS: TO COVER THE 6 HPCM REQUIREMENTS

TVAC & APTC	
Pressure:	<1E-6 mbar / N2
Temperature:	-180 °C / +160 °C
Cycles:	20 + 80

ATOX	
Fluence:	2.7E21 atoms/cm2
Pressure:	<1E-6 mbar
Typical atomic oxygen (AO) energy:	5.5 eV

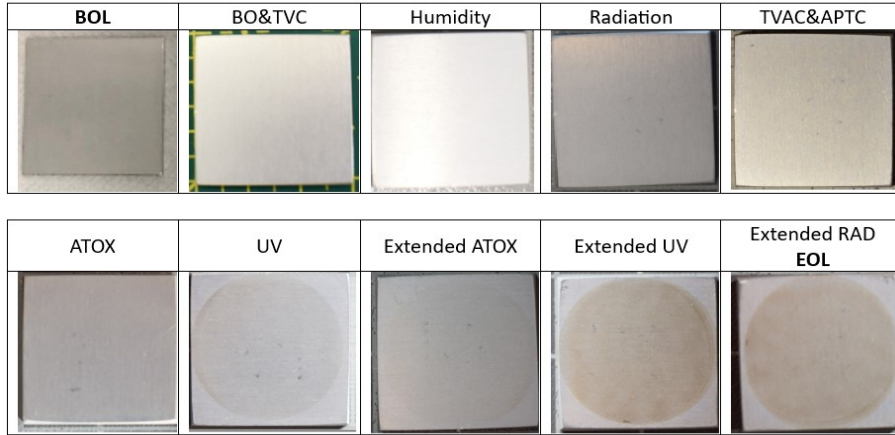
SURTEC 650 RTU

- slight darkening
- All samples passed the visual inspection and the adhesion (tape-lift) tests after each ageing tests.

Surtec 650RTU passed the aging tests successfully and therefore considered to be qualified.

TO property	BOL	After TVAC	After ATOX	After UV	After Ext. ATOX	After Ext. UV	After Ext. Rad. EOL	Δ
Solar absorptance	0.29	0.33	0.32	0.32	0.31	0.42	0.44	+0.15
Thermal emittance	0.03	0.05	0.04	0.04	0.02	0.02	0.04	+0.01

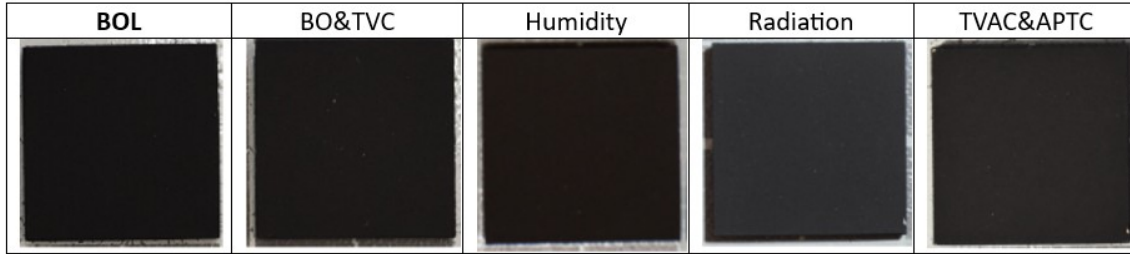
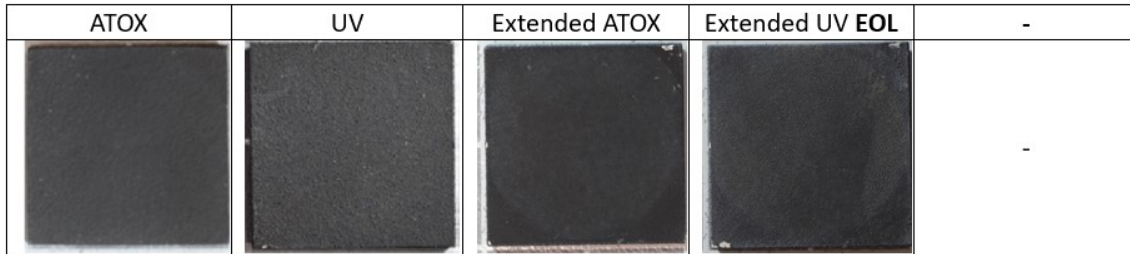
- Visual change due to aging is negligible.
- All samples passed the adhesion (tape-lift) test after each ageing tests.

PNC coating passed the aging tests successfully and therefore considered to be qualified.

TO property	BOL	After TVAC	After ATOX	After UV	After Ext. ATOX	After Ext. UV EOL	Δ
Solar absorptance	0.97	0.97	0.97	0.97	0.97	0.97	0.00
Thermal emittance	0.93	0.90	0.92	0.95	0.96	0.96	+0.03

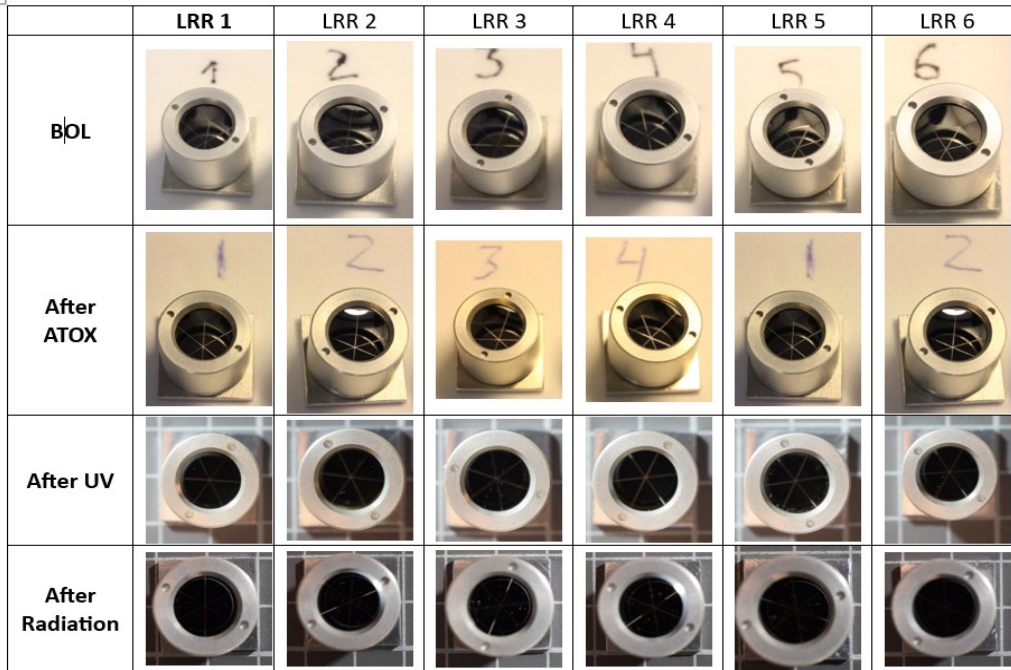
- LRR units have been subjected to the same ageing qualification tests as the coatings
- Critical functions are the optical properties (WFE, FFDP, reflectivity)

CI number		BOT		After ATOX		
LRR S/N	CCR S/N	WFE (532nm)	R(%)	WFE (633nm)	R(%)	ΔR (%)
#1	ADM-002	20.727	59.7	28.95	57.5	3.8%
#2	ADM-003	22.344	59.6	40.08	55.4	7.6%
#3	ADM-004	33.207	59.8	70.96	57.3	4.4%
#4	ADM-005	41.256	59.3	68.98	54.6	8.6%
#5	ADM-006	26.482	60.3	40.39	56.7	6.3%
#6	ADM-007	19.907	58.5	52.14	57.3	2.1%

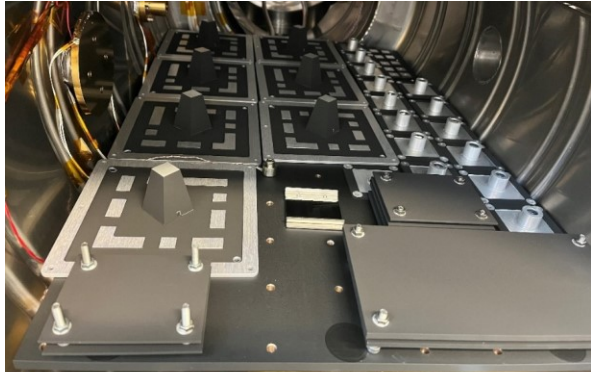
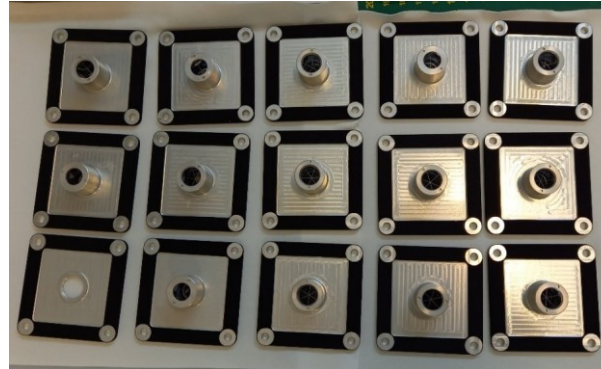
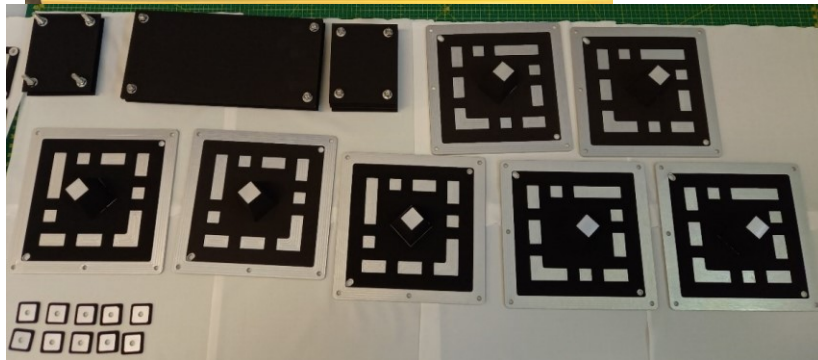
BAKEOUT

- Bakeout is performed as the final step of the manufacturing, and it is used for pre-conditioning of hardware for space use and cleanliness improvement.

Bakeout	
Vacuum level:	<5E-6 mbar,
Bakeout temperature:	80°C
Duration:	minimum 72 hours,

- All items passed the inspections and measurements.
- Cleanliness measurement result: $0.12 \times 1E-07$ g/cm².
- Bakeout of all items is considered successful.

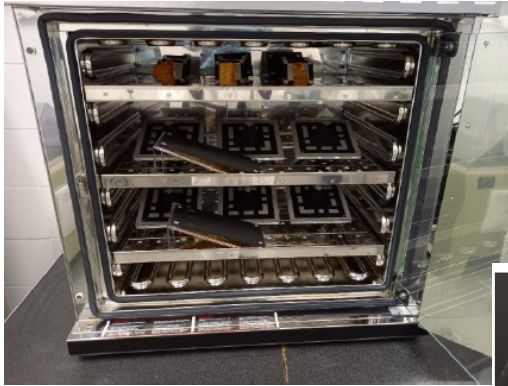
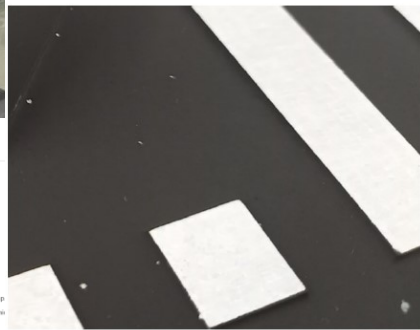
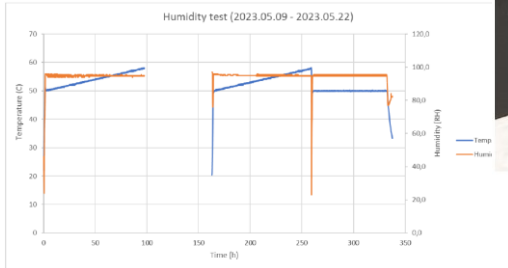
HUMIDITY (DAMP HEAT) TEST

- Humidity-, or damp heat test is a control for corrosion resistance of exposed surfaces like conversion coating and topcoats stored in Class 6 (indoor, controlled) environment.

Humidity	
Humidity level:	95% RH
Temperature:	50°C
Duration:	240 hours

- unexpected power outage.
- Test articles spent 2 days under uncontrolled conditions.
- Visual failure has been observed on 3D Markers and corresponding witness plate painted with PNC after the humidity test.
- All other items have passed the visual inspection.
- All items passed the adhesion tests.

- Visual failure has been identified after the humidity test on 3D Markers S/N ADM-001, ADM-002 and ADM-003. All remaining models subjected the humidity test passed the test successfully. As test chamber failure has been identified as the root cause of the NC and repeated humidity test was performed successfully, the humidity test of the subjected models have been declared successful.

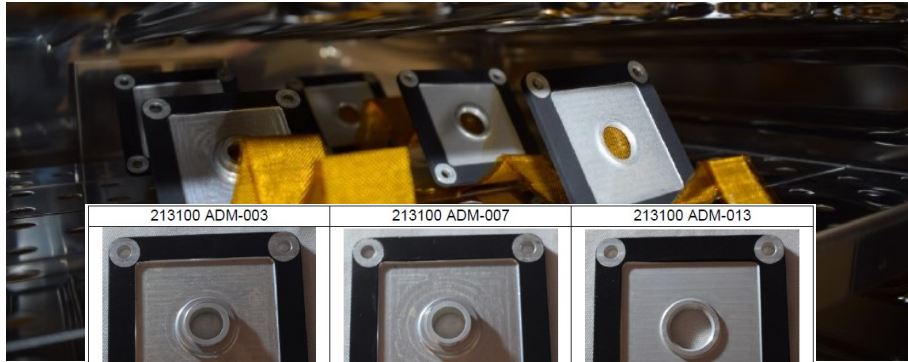
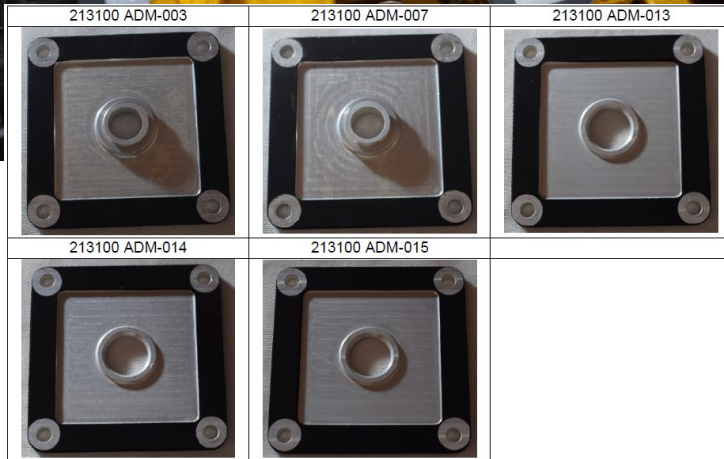
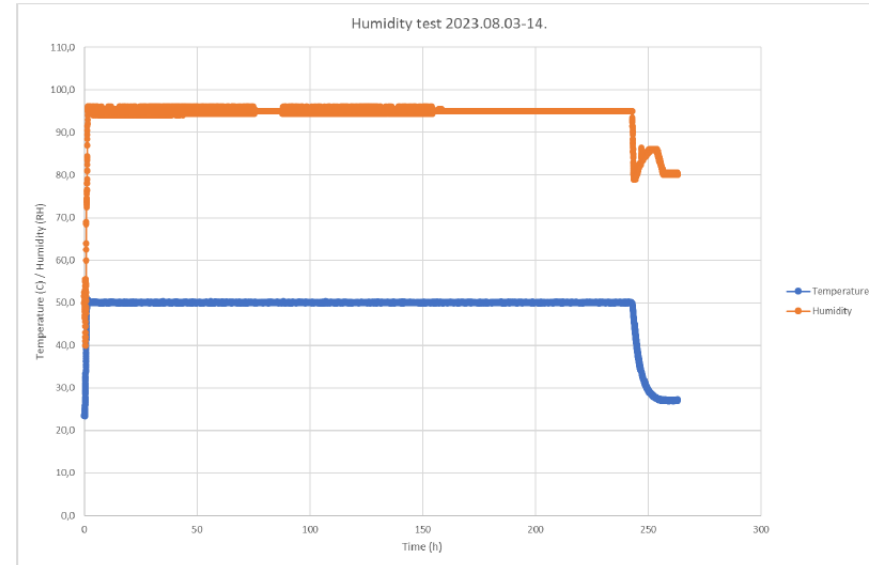
HUMIDITY (DAMP HEAT) TEST-REPEAT

- All items passed the visual inspection and the tape-lift test.
- Based on the test results of the repeated humidity test, the unexpected test chamber failure has been found as the cause of the NC.
- Based on these results, the humidity test of QMs has been considered successful.

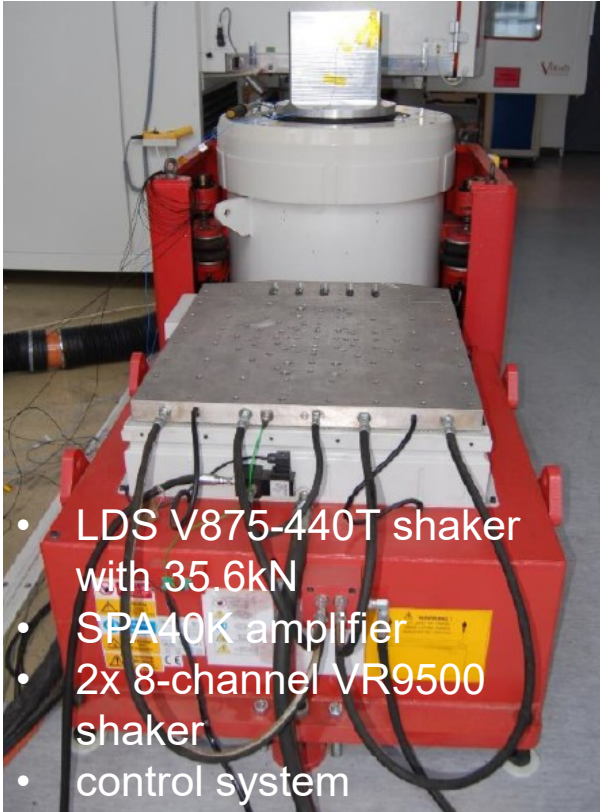
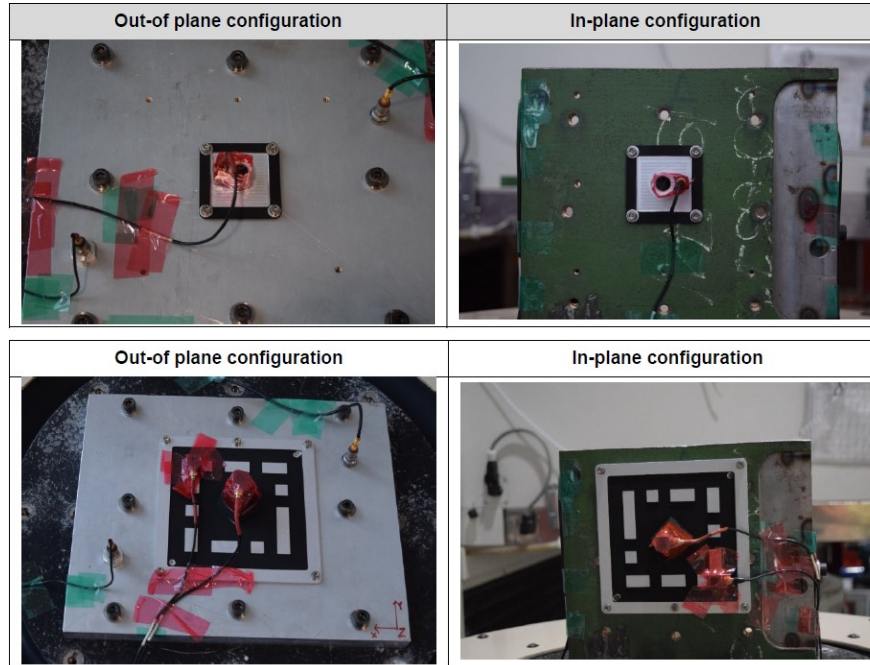
VIBRATION TEST

- Vibration test is performed to prove that equipment is free of workmanship defects and will be able to survive launch and on-orbit loads without loss of functionality.

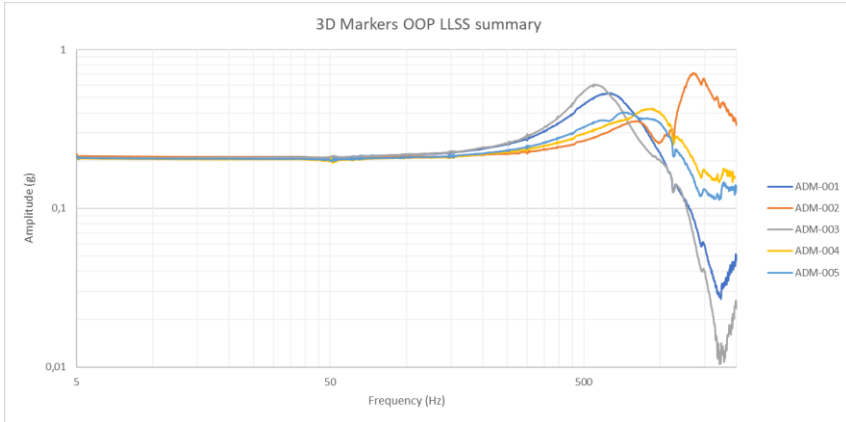
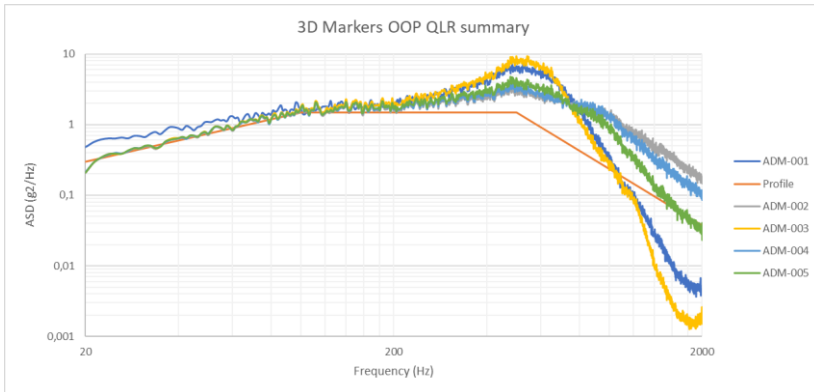
VIBRATION TEST-3D Marker results

CI number	First frequencies (Hz) – Low level sine sweep		
	Z	X	Y
223000 ADM-001	641	595	599
223000 ADM-002	814	594	592
223000 ADM-003	568	606	599
223000 ADM-004	937	597	599
223000 ADM-005	726	597	599

CI number	First frequencies (Hz) – Qualification level random		
	Z	X	Y
223000 ADM-001	541	588	588
223000 ADM-002	N/D	580	580
223000 ADM-003	541	588	588
223000 ADM-004	N/D	588	588
223000 ADM-005	N/D	588	588

- There was no sign of cracks, deformation, disintegration during and after the vibration test on the test articles.
- There was no sign of cracks, deformation, disintegration during and after the vibration test on the LRR units.
- All items withstood the QL loads without degradation.
- No nonconformances have been revealed as a result of the vibration test.
- 3D measurement results after the vibration test showed no major deviations - significantly out of tolerance- compared to ones recorded before the vibration test.
- All items passed the grounding measurement after the vibration test.
- Vibration test of the 2D Markers Qualification Models in the configuration in terms of random and sine test is considered successful.

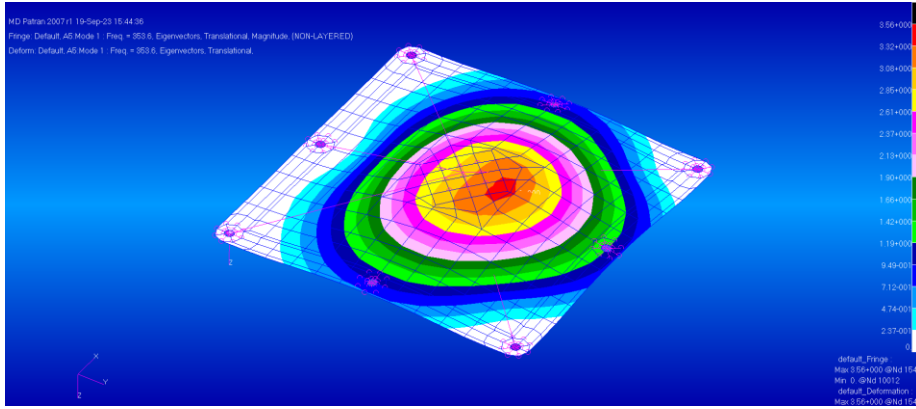
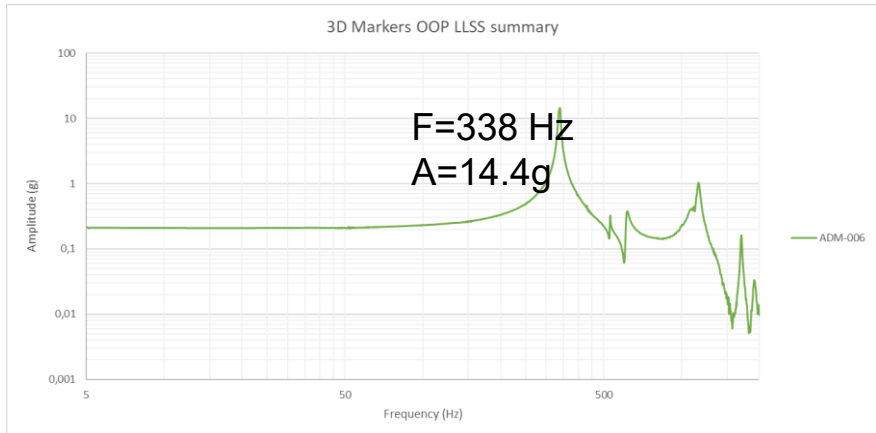
VIBRATION TEST-3D Marker results-OOP LLSS-thermal washers configuration

- Analysis resulted 354Hz which is in line with the 338 Hz measured frequency.
- Requirement for secondary structure is 140 Hz for the first main mode, which is well above the requirement.

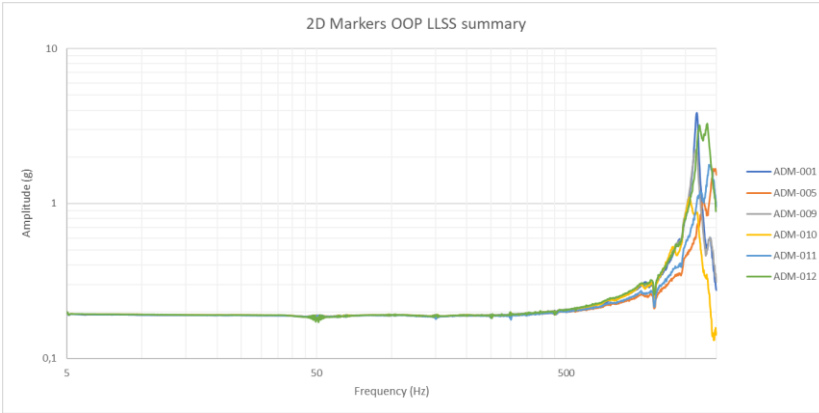
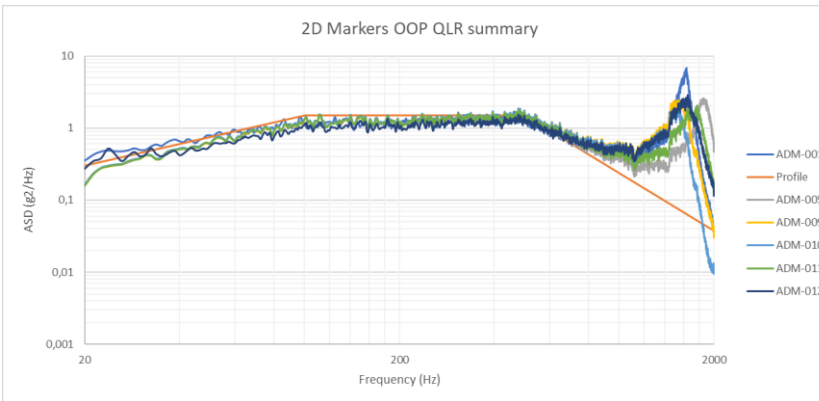
VIBRATION TEST-2D Marker results

CI number	First frequencies (Hz) - Low level sine sweep		
	Z	X	Y
213000 ADM-001	1 668	604	604
213000 ADM-005	1 977	604	604
213000 ADM-009	1 658	604	-
213000 ADM-010	1 559	604	-
213000 ADM-011	1 864	604	-
213000 ADM-012 (THW)	1 708	602	-

CI number	First frequencies (Hz) - Qualification level random		
	Z	X	Y
213000 ADM-001	1 641	595	594
213000 ADM-005	1 851	594	594
213000 ADM-009	1 540	594	-
213000 ADM-010	1 485	594	-
213000 ADM-011	1 770	594	-
213000 ADM-012 (THW)	1 653	594	-

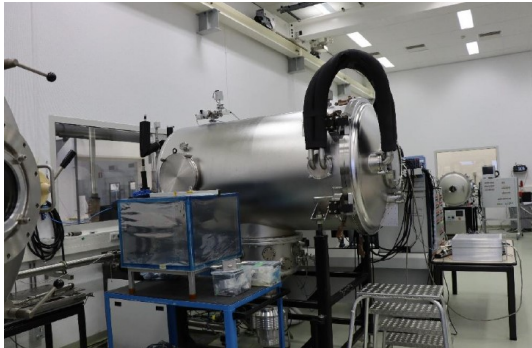
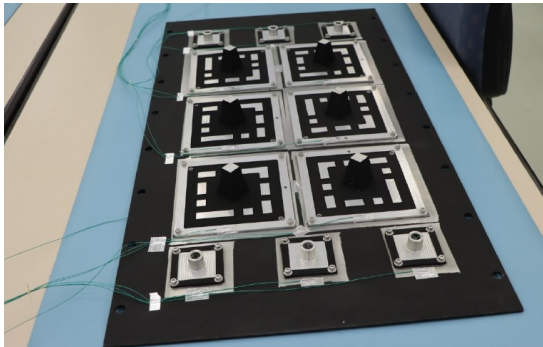
THERMAL VACUUM CYCLING TEST

The requirement for the cold temperature of $T=-180^{\circ}\text{C}$ was not met during the test. The minimum temperature reached during the first cold cycle on the TRP (average of all test specimens) was $T=-175^{\circ}\text{C}$ which required a dwell time of 26.5 hours.

Decision has been made to reduce the cold cycle temperature requirement to $T=-170^{\circ}\text{C}$.

- Temp. Range is **$-170^{\circ}\text{C} / +160^{\circ}\text{C}$**
- $P=5.5\text{E}-06$ mbar
- 8 cycles

- All items passed the inspections & measurements
- No nonconformances have been revealed as a result of the thermal vacuum cycling test
- Based on these results, the thermal vacuum cycling qualification test of QMs has been considered successful²⁵

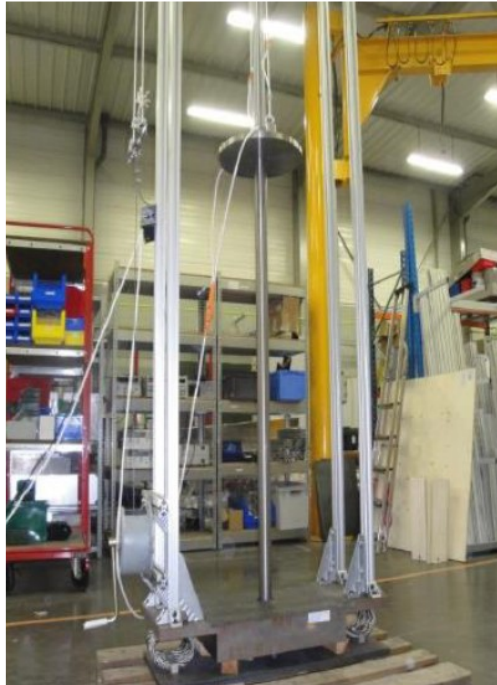
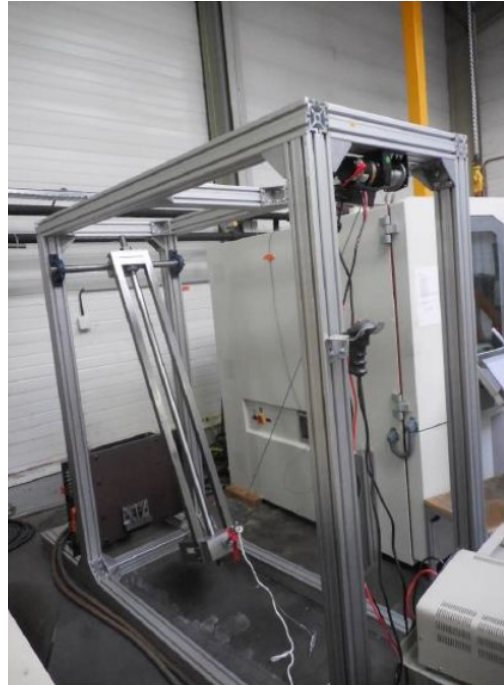
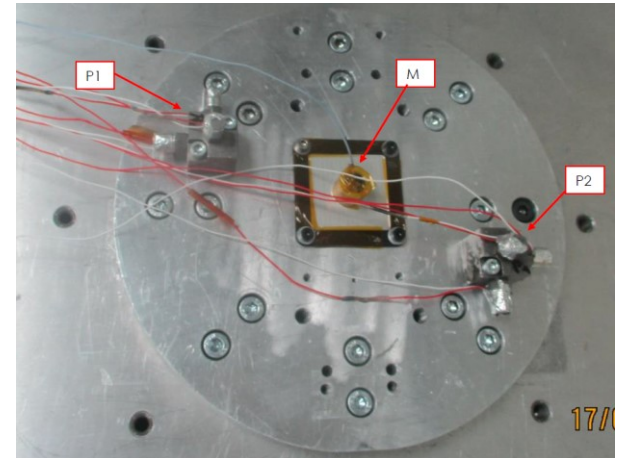
SHOCK TEST

Shock test is performed to qualify the hardware against mechanical environmental loads during the launch phase.

- Shock levels are controlled by two tri-axial accelerometers (P1 and P2)
- Measurement accelerometer (M) is located on the HW

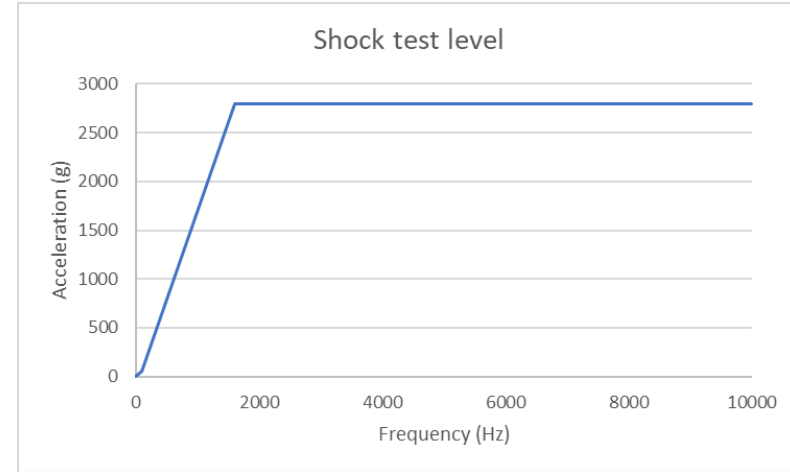
SHOCK TEST-levels

STANDARD	Handbook ECSS-E-HB-23-25A		
FREQUENCY (Hz)	100	1600	10000
ACCELERATION (g)	60	2800	2800
AXIS	X, Y and Z		
SAMPLING RATE	204,8 kHz		
DAMPING RATE	Q =10 (5%)		
SRS ANALYSIS	1/24 of Octave		
NUMBER OF SHOCK	1 per axis

The profile is the same for both benches. Z axis is performed on free fall test bench, X and Y axes are performed on pendulum hammer test bench.

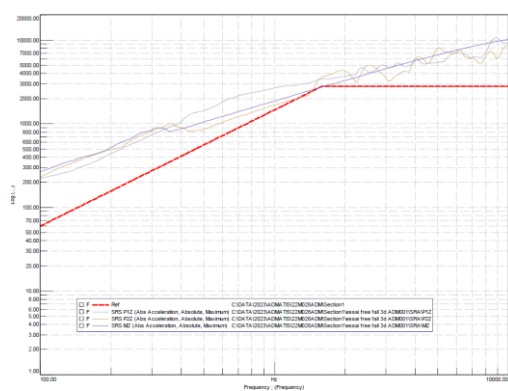
Z-SRS

SHOCK TEST RESULTS-3D Marker

- There was no sign of cracks, deformation, disintegration during and after the vibration test on the test articles.
- There was no sign of cracks, deformation, disintegration during and after the vibration test on the LRR units.
- Dimension check showed minor deviation (ADM-012): The true position of the tube is out of tolerance with 0.0311 mm (tolerance is 0.1 mm).
- All items withstood the QL loads without degradation
- All items passed the grounding measurement after the shock test.
- All items passed the torque check.
- Based on these results, the shock test of QMs has been considered successful.

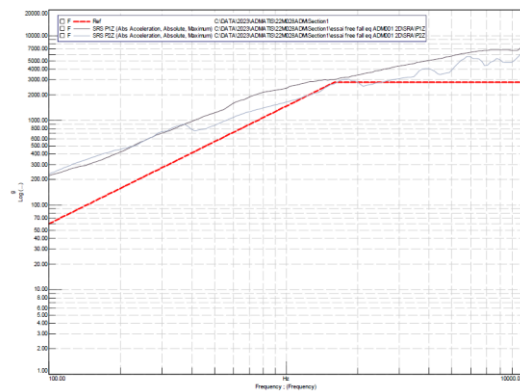
Z-SRS

SHOCK TEST RESULTS-2D Marker

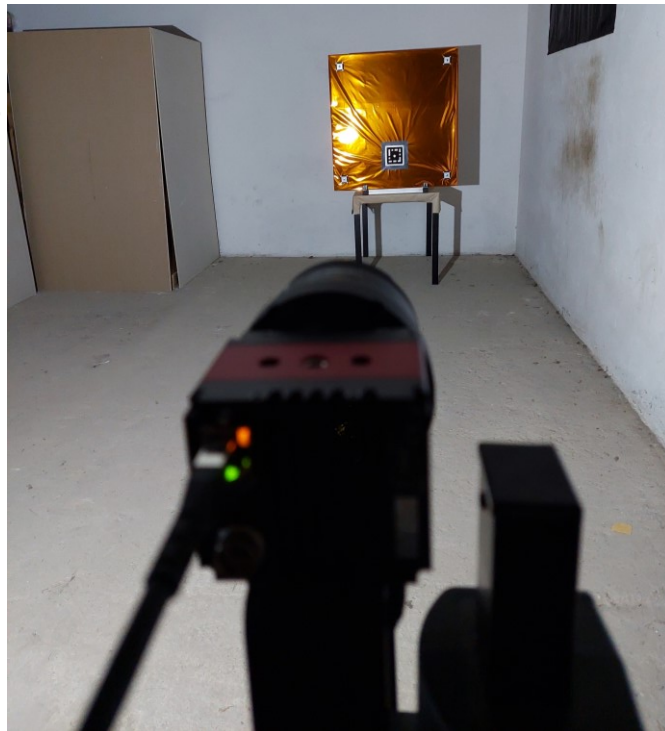
CONTRAST MEASUREMENT

Pitch angles of test board

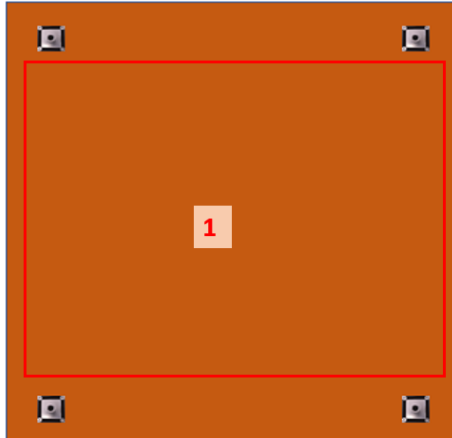
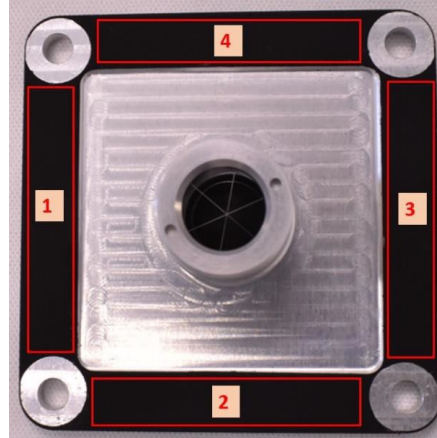
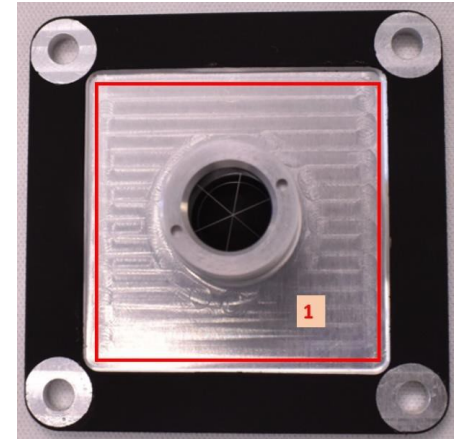
The evaluation is performed using the **Michelson Contrast** formula:
$$\frac{I_{max} - I_{min}}{I_{max} + I_{min}}$$

I_{max} can be considered as average intensity value of the target, while I_{min} is the average intensity of the background.

To calculate the average Intensities ROIs (Region of Interest) marked have been applied:

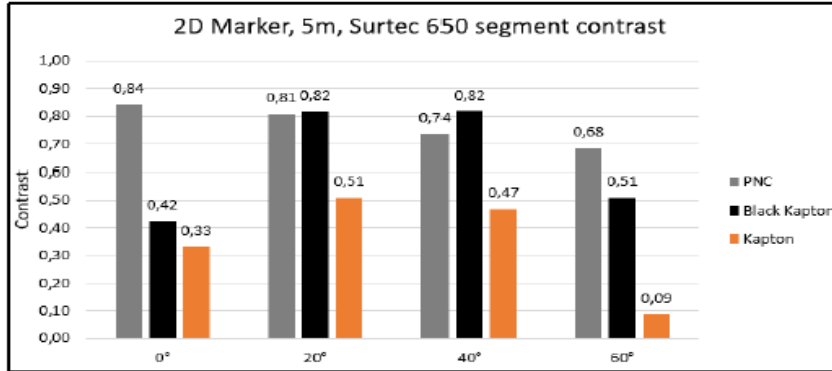
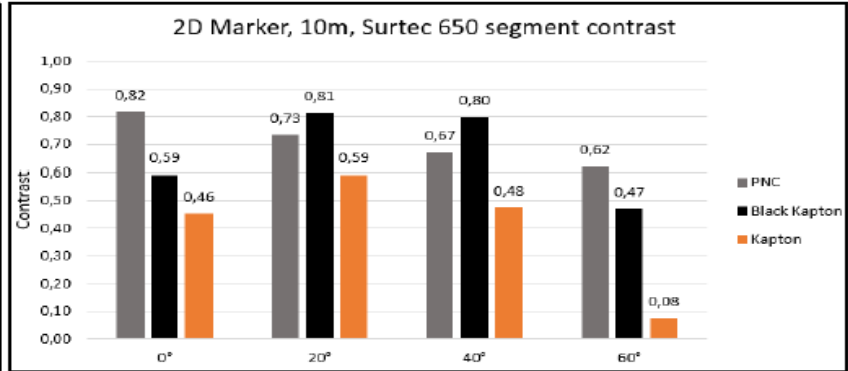
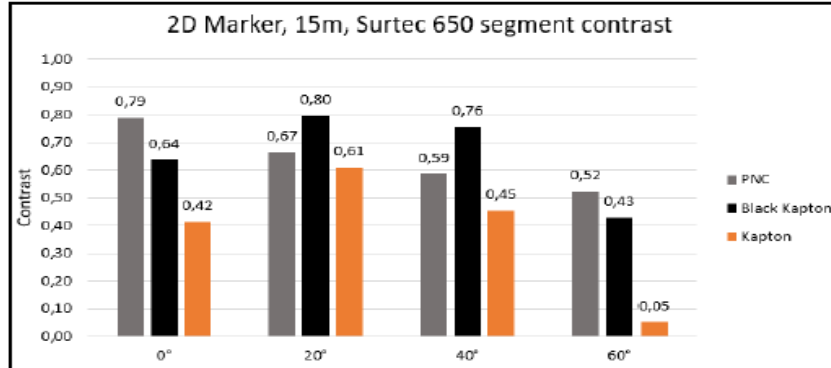
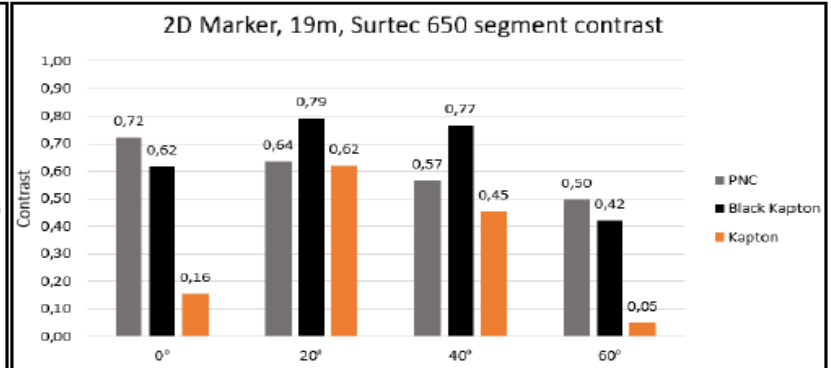
VNIR

CONTRAST MEASUREMENT RESULT

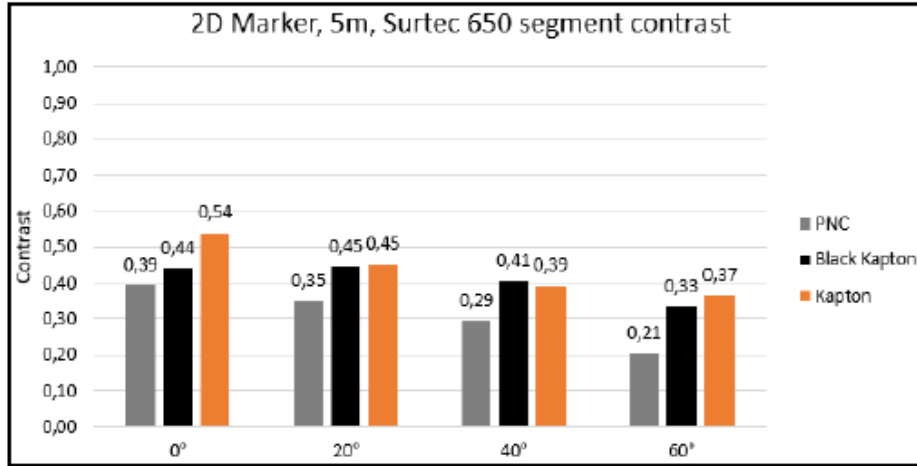
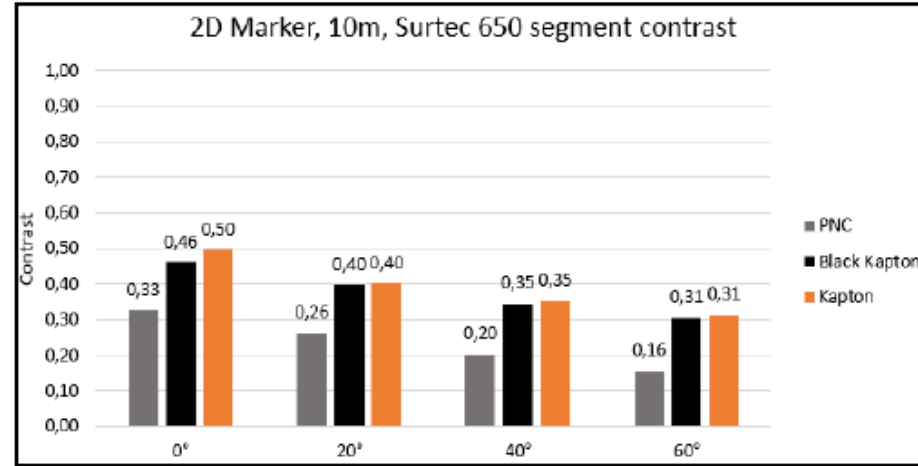
TIR

CONTRAST MEASUREMENT RESULT
