Eliminating Measured Radiation Effects to go for FM-Level Mixed Signal Design

MILLNER, Sebastian (TH Nürnberg - Ohm); LÜCK, Volker (TESAT);

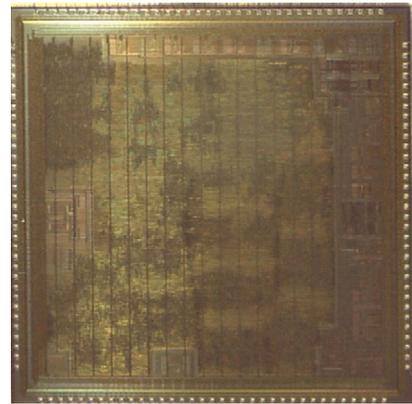
Fig. 1. Die photo of RUCA2 ASIC

The RUCA ASIC is based on the experience, we made with the prototype presented in [7]. It is designed according to ECSS-ST-60-02C [6]. A die photo is shown in Fig. 1. Some key facts are presented in TABLE I. The large die size and the high number of standard cells for a 180 nm mixed-signal design is eye catching. It is a direct result of radiation testing of the predecessor prototype. No memory macros could be used within RUCA and consequently, all memories needed to be implemented using Flip-Flops.

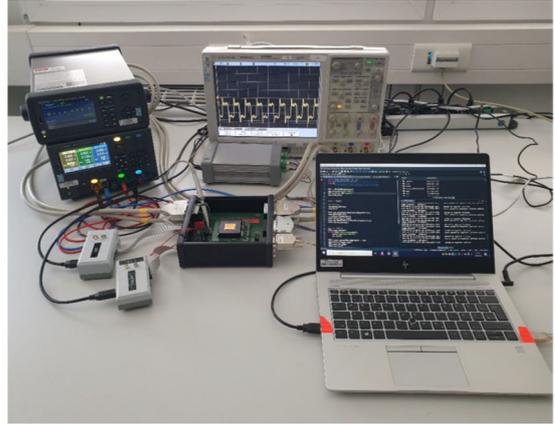
Fig. 3. Measurement setup for RUCA TID measurement campaign

For measurements, each device is removed from its irradiation board and mounted onto the measurement board in the middle of Fig. 3. In addition to the printed circuit board (PCB), there is one laboratory power supply, a source meter for pushing currents and voltages onto the device under test (DUT), a data acquisition unit (DAU), an oscilloscope for measurement of the clock period, two communication boxes enabling SPI and JTAG communication with the DUT and a laptop for test automation. The setup is fully automated to execute all tests within less than 6 minutes without any user interaction. Results are written into text files, which can directly be evaluated after each measurement.

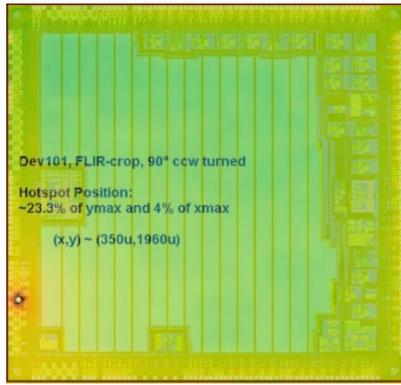
Fig. 10. RUCA1 FLIR-Investigation showing hot spot in IO-Ring

At the beginning, the hypothesis was a latch-up, within the level shifted IOs, as the main symptom was a high current on SPIVCC and the failure of the external interface. Analysis methods have been resistor measurements – at first concentrated on SPIVCC to GND, Forward Looking Infra-Red (FLIR), optical inspection, Layout and circuit analysis and further radiation tests. Optical inspection did not show anything. FLIR was very helpful, as the spot draining the high current could directly be identified. One of the images can be found in Fig. 10. The marked hot spot is within the area of the level shifted IOs. Consequently, the focus has been the observation of these IOs. As there have been several samples with different hot spots, it has been possible to trace the failure to a single circuit – a huge transistor capacitor used for power blocking in the area between the IOs.
