Thermal Balance Test and Thermal Model Correlation of FLORIS PFM

ESTE W 2025 – 10/09/2025

- **Single Instrument** of mission **FLEX**:
 - an imaging spectrometer that detects visible light
 - ICU (Instrument Control Unit)
- **Mission Objective**: Quantitative measurements of the solar induced **vegetation fluorescence**
- **Satellite** prime contractor: **TASF**
- **Instrument** contractor: **LEONARDO**

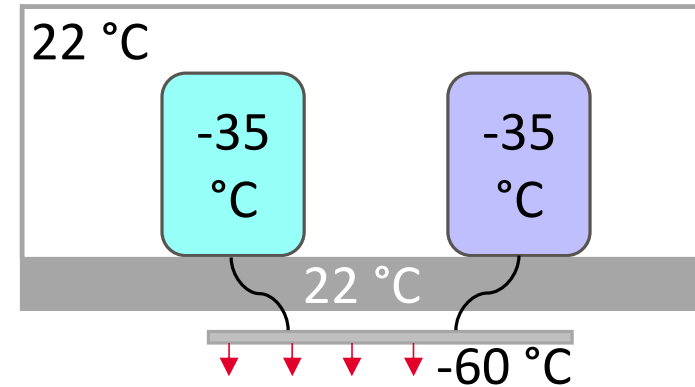
Temperatures

Subsystem	Operative	Non Operative
Detectors Unit	-35 °C	< -50 °C
Optical Bench	22 °C	1 °C
Radiator	< -60 °C	< -60 °C

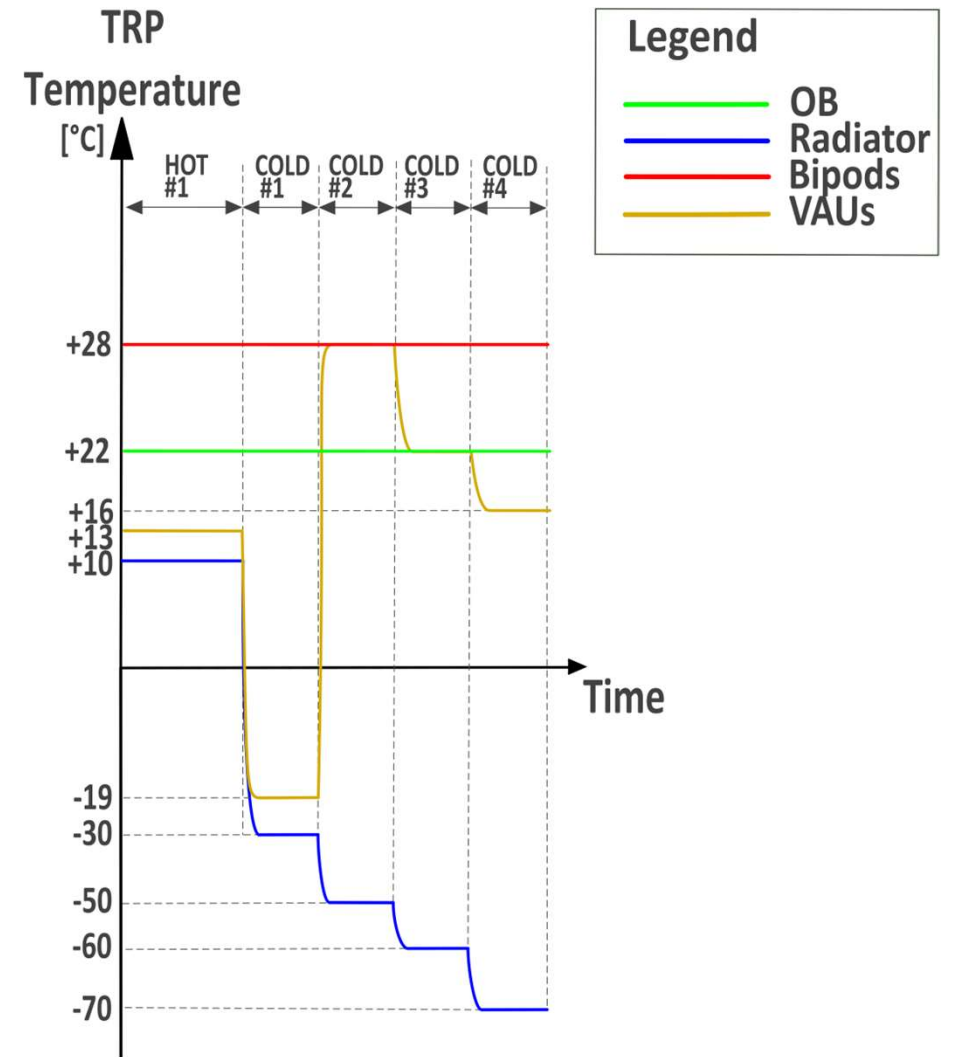
Test Overview and Goals

The **planned** profile foresaw **5 phases**:

- **1 hot non operative**
- **1 cold non operative**
- **3 cold operative**
