# Space Debris from Spacecraft Degradation Products Final Presentation

Funding programme TRP ; ESA Contract no. 4000113047/14/NL/LF

The project aim was to study the degradation and generation of debris of external spacecraft materials when exposed to long term space environment (for LEO and GEO conditions).

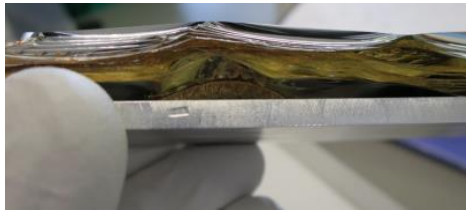
## ex situ visual inspection shows strong degradati

- mylar foils appeared brittle and falling apart (debris generated from handling)
- velcros is discoloured/bended (local mechanical stress at mylar foils) and brittle loops
- Polyester fleece spacers and dacron are OK

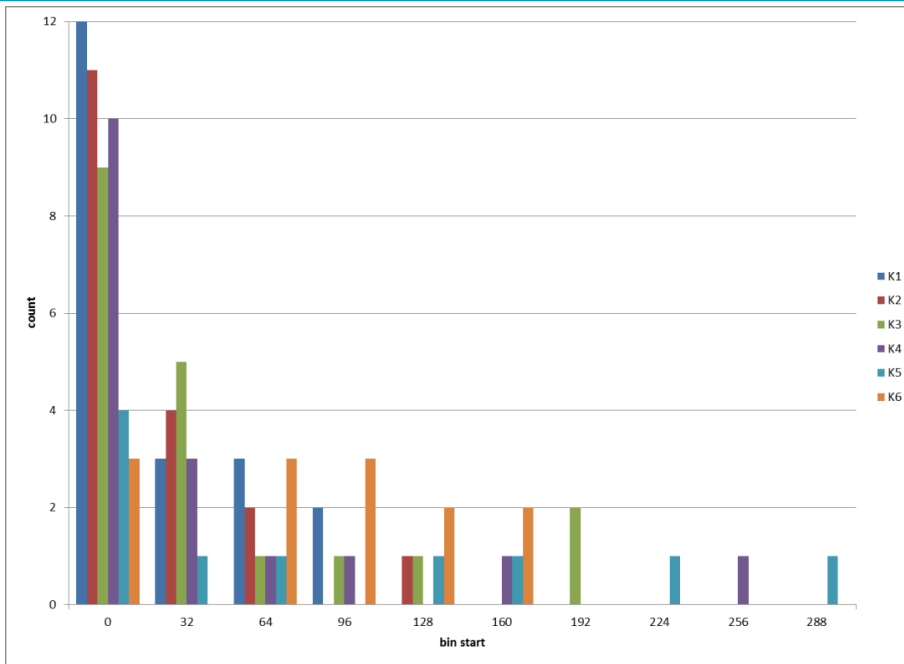
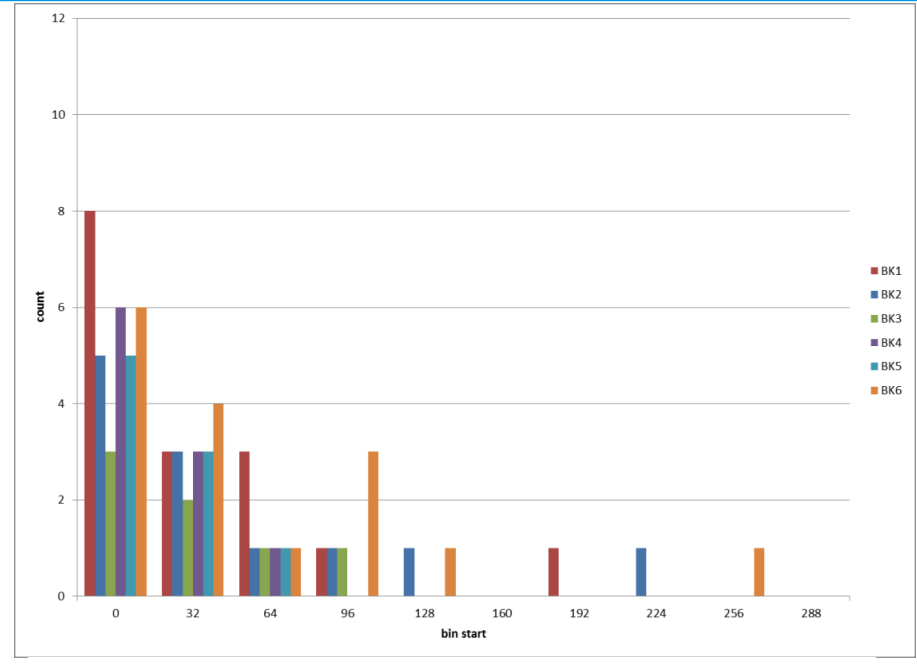
# Activity – Debris investigation: MLI debris characteristics (Mylar foils)

Distribution shapes are similar for each layer and for both K and BK MLIs

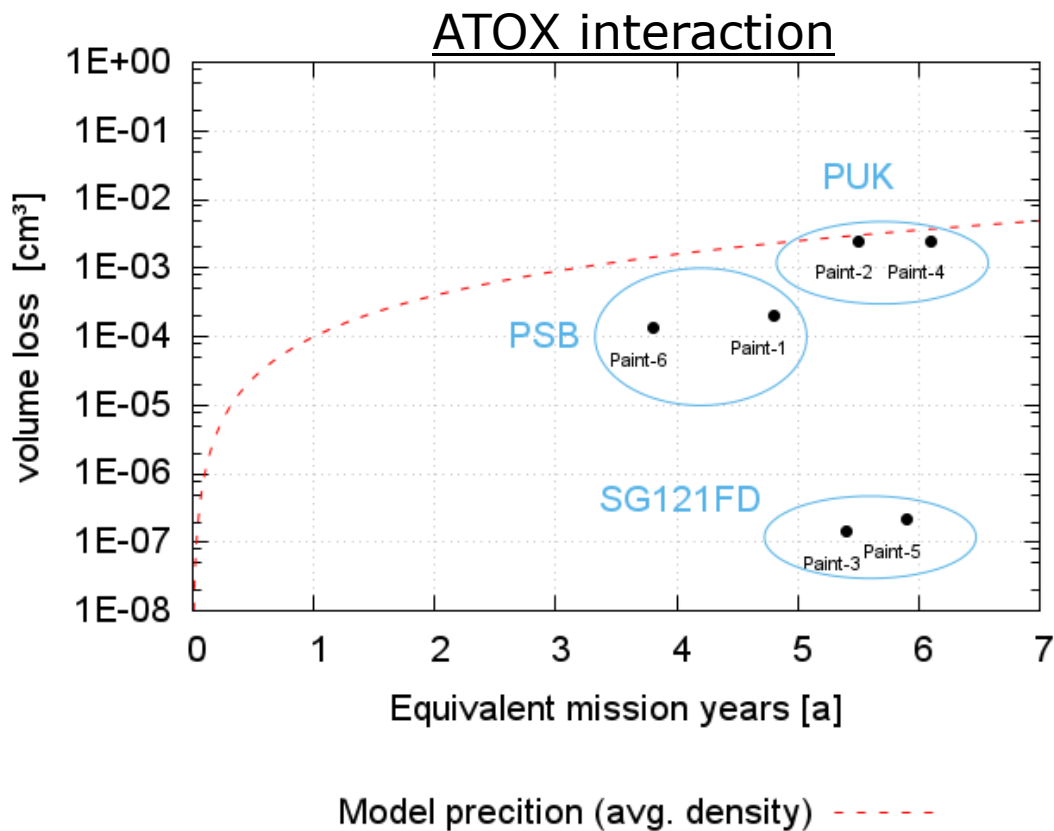
## Paint LEO ATOX interaction

Comparison: experimental observations and current calibration
