COMPATIBILITY OF WELDED PROPELLANT SYSTEMS WITH NEW GREEN PROPELLANTS

SAMANTHA GRAHAM PROPULSION ENGINEER EUROPEAN ASTROTECH

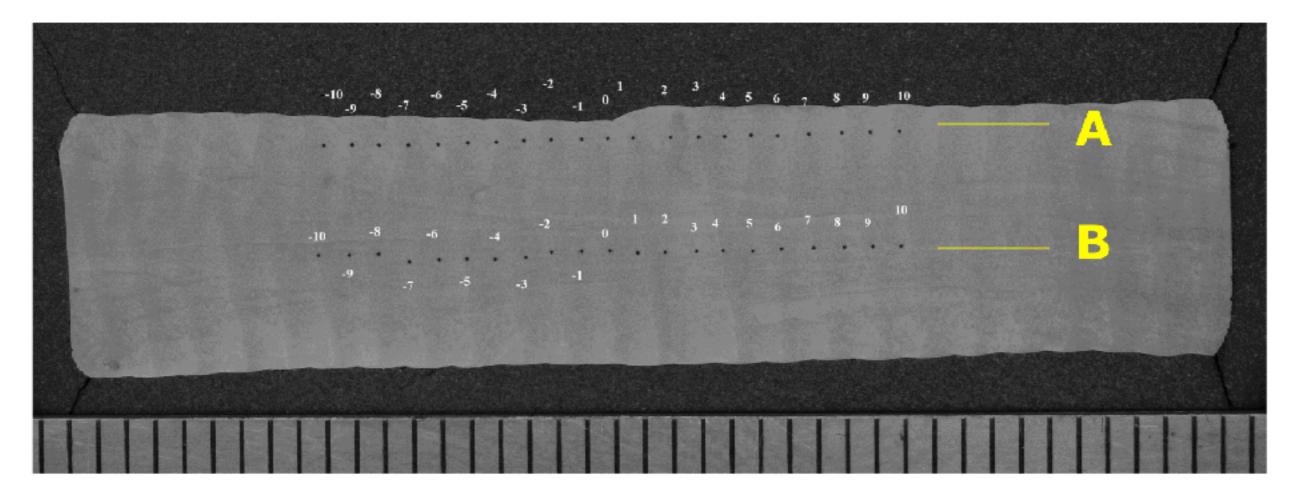
HARDNESS TESTING

- Two profiles (see below):
 - A. Sub surface
 - B. Along mid-thickness
- Suggested space between indentations 1mm
- Suggested indentation load 5 Kg

• No obvious effect of environmental condition on sample hardness
